Nord Stream 2

Archaeological analysis of geophysical data

Baltic Sea Swedish EEZ

© 2016 Maritime Museum
Archaeological Report 2016:11
ISSN 1654-4927

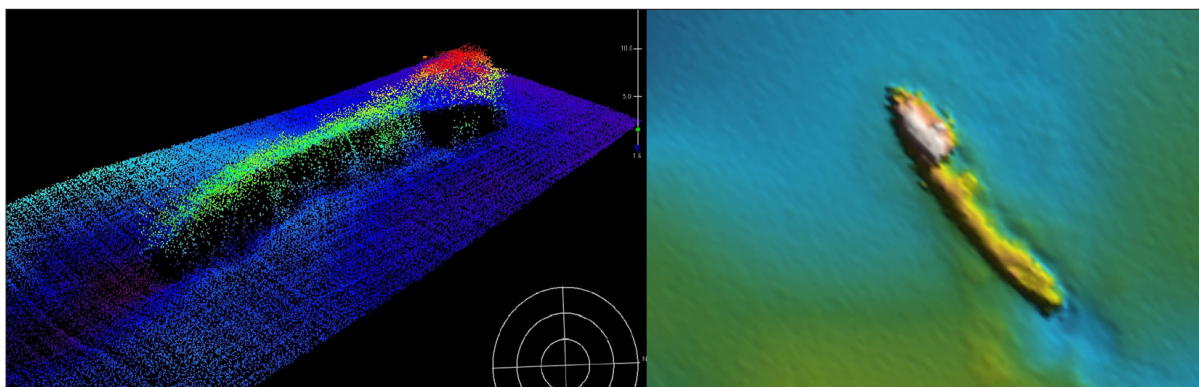
S-R17-3360

Fig. 3. Sonar images of wreck S-R-17-3360 © Swedish Maritime Administration.

The wreck was found by the Swedish Maritime Administration in 2009. The 120 meter long wreck lies on its side. Based on Fugro's and the Swedish Maritime Administration's sonar data it seems to be a cargo ship from the 20th century. It is therefore probably not a cultural monument based on the criteria that it has foundered before 1850, but it might be a younger wreck of cultural value.

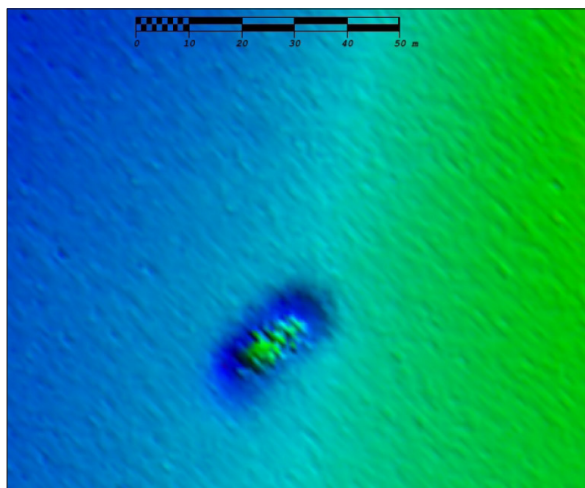
Fig. 4. Sonar image of wreck S-R17-4285 © Swedish Maritime Administration.

The wreck S-R17-4285 was found by the Swedish Maritime Administration in 2009. This is a 20 meter long wreck and according to the sonar image the wreck seems to be intact. On basis of the sonar image it's impossible to tell if it has foundered before 1850.

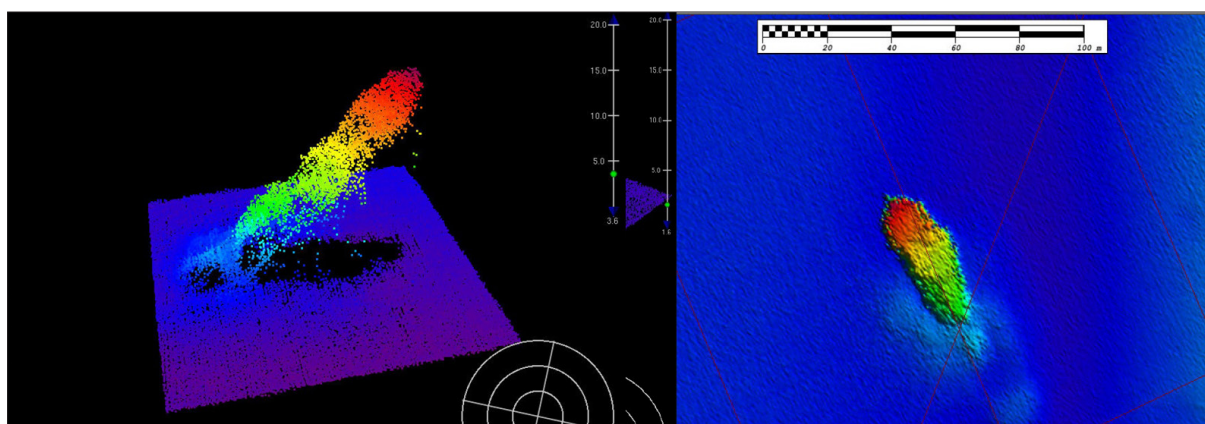
The wreck was found by the Swedish Maritime Administration in 2009. The 45 meter long wreck seems to have its bow (or stern) buried deep into the bottom sediment.

Based on Fugro's and the Swedish Maritime Administration's sonar data it seems likely that the wreck has foundered after 1850. It is probably not a cultural monument based on the criteria that it has foundered before 1850, but it could be a younger wreck of cultural value.

Fig. 5. Sonar images of wreck S-R19-0368 © Swedish Maritime Administration.

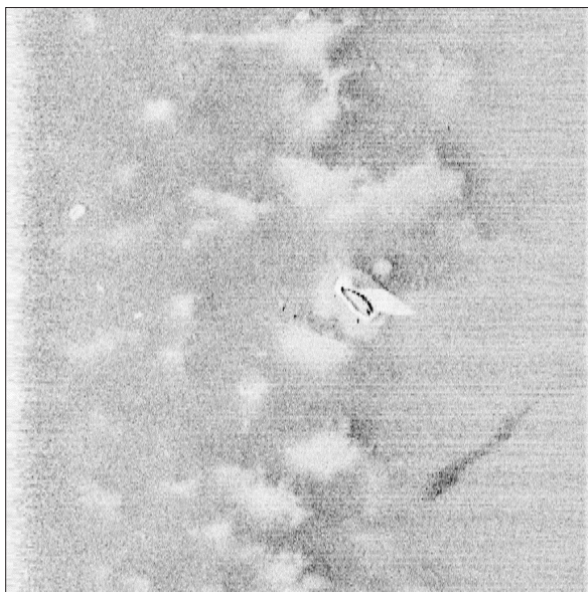
This indication is an 8 meter long wreck, but based solely on the sonar image it's impossible to tell if it has foundered before 1850. It could be a wooden wreck and therefore a possible cultural monument. According to the sonar image the wreck seems to be relatively intact.

Fig. 6. Sonar image of wreck S-R19-0998 © Fugro.

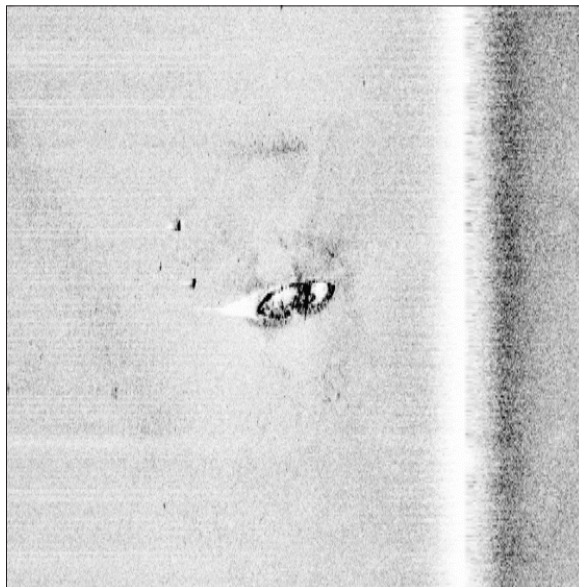
Fig. 7. Sonar image of wreck S-R19-1026 © Fugro.

This indication is interpreted as an 18 meter long wreck, but based on the sonar image it is impossible to tell if it has foundered before 1850. It might be a wooden wreck and therefore a possible cultural monument. According to the sonar image the wreck seems to be relatively intact.

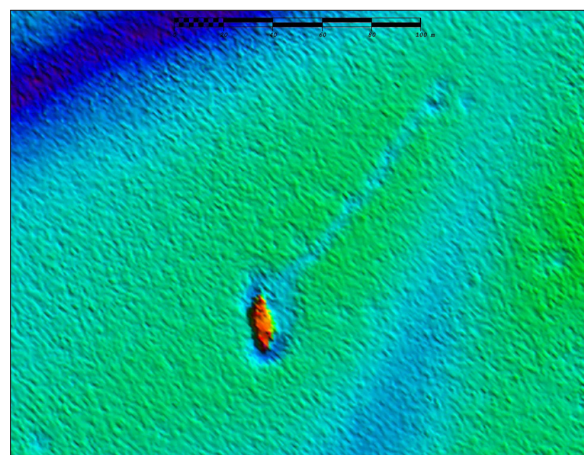
This 25 meter long wreck was found during the Swedish Maritime Administration's survey in

Fig. 10. Sonar images of wreck S-R24-0735 © Fugro and Swedish Maritime Administration.

2009. Based on the sonar image it's impossible to tell if it has foundered before 1850. It could to be a wooden wreck and therefore a possible cultural monument. According to the sonar image the wreck seems to be relatively intact.

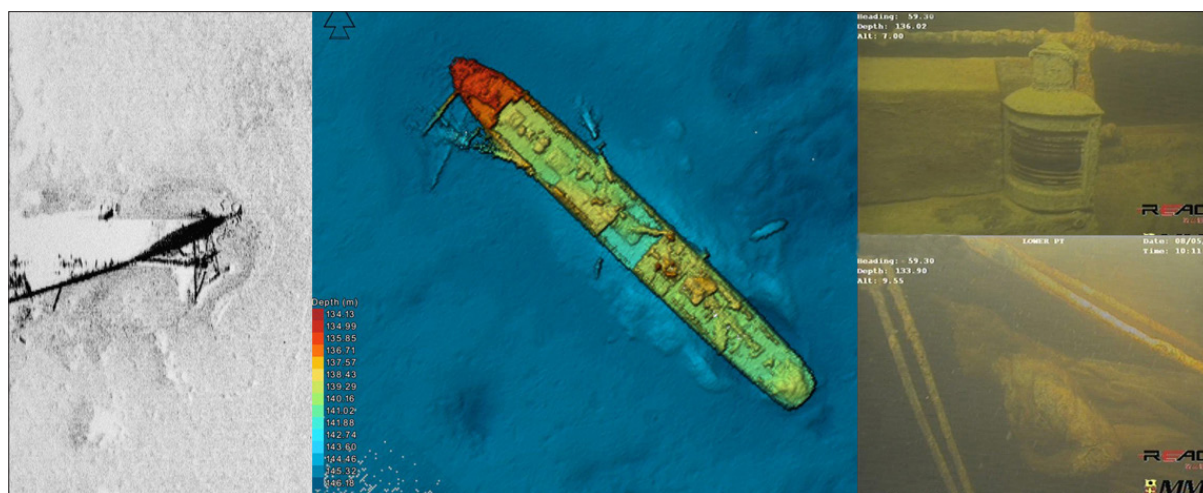
This is an 81 meter long and 9 meter wide wreck. MMT has done a ROV-filming and bathymetry survey of the wreck. The ROV-pictures shows that the wreck appears to be made of steel, with iron rails, navigations lights of metal with "fresnel lens", lifeboats with lifting hooks of iron and a figurehead (fig. 11). MMT interprets it as an old steamer from the early 20th century (MMT 2016a) and it might be so. The details and the size, length/width ratio (1/9) indicates that it could be

Fig. 11. Sonar image, multibeam image and photos of port navigation light and bow figure head at S-R24-5317 © Fugro and MMT.

a bark ship built around 1900, possibly foundered around the 1st or 2nd world war. Traditional steamers were usually wider and did not have figure-heads as often as sail ships.

The size and the details, like the navigation light suggest that the wreck has foundered in the early 20th century, but if it is deemed as of special value it might be considered as a cultural monument by the county administrative board. According to the sonar image the wreck seems to be relatively intact except the associated debris (S-R24-5318 and S-R24-5389) near the wreck.

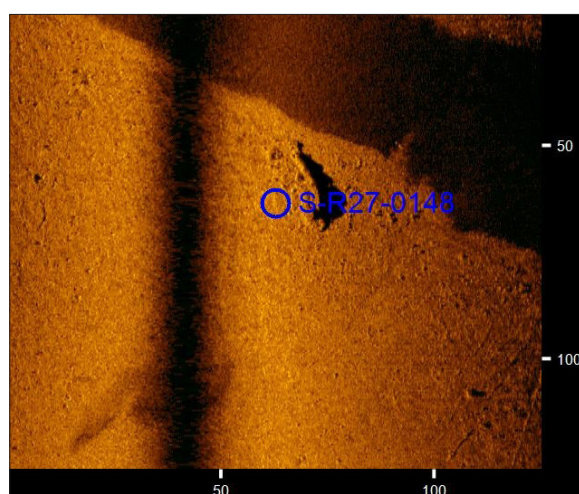
This indication is classified as a possible wreck by SMM and Fugro's has classified it as a "mound".

Fig. 14. Sonar image of possible wreck S-R27-0148 © Fugro, edited by Mikael Fredholm, Maritime Museum.

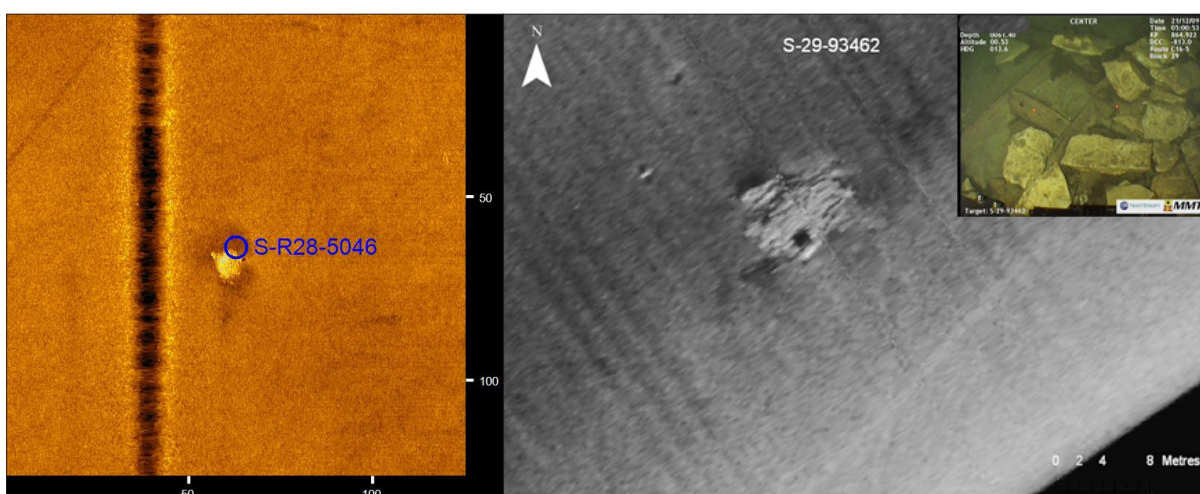
S-R28-5047 and S-R28-5046

The indications are the same as Nord Stream indication S-29-93462. This is a clinker built wooden wreck with ballast/cargo of limestones and iron. It is a cultural monument, possibly a medieval ship (Fredholm 2010: page 27) and the wreck corresponds to the definitions in the Swedish Heritage Conservation Act (1988: 950) as a cultural monument. The main wreck area is concentrated

Fig. 17. Sonar image and ROV-photo of wreck S-R28-5046/5047 (S-29-93462) © Fugro and MMT, edited by Mikael Fredholm, Maritime Museum.

except an associated container approximately 30 meters southeast of the wreck and a ship timber 15 meter northwest of the wreck. The wreck area is around 30×30m (Nord Stream, 2009).

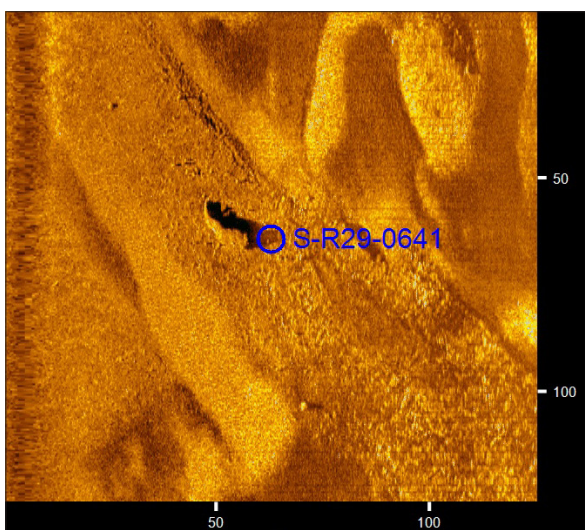
Fig. 19. Sonar image of S-R29-0641 © Fugro, edited by Mikael Fredholm, Maritime Museum.

A 12 meter long indication that might be debris, stones, geology or a wreck.

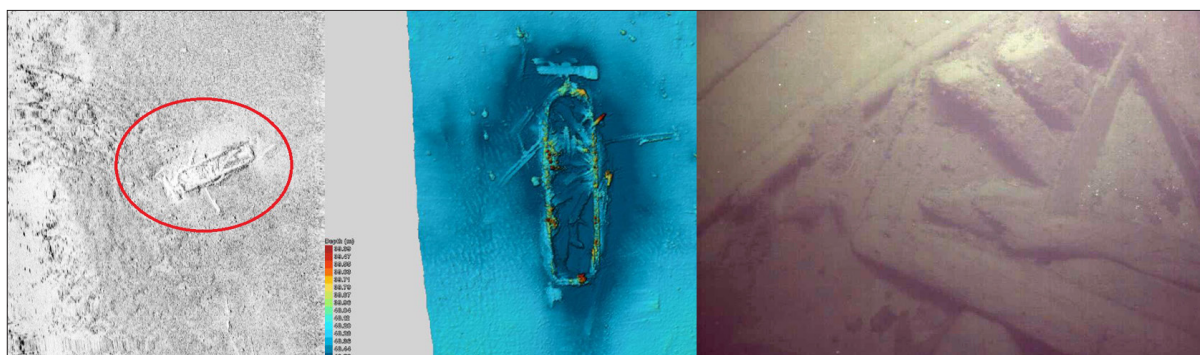
Fig 22. Sonar image, multibeam image and photo of S-R30-0997 a © Fugro, MMT, MMT.

This is 24 meter long wreck. According to the sonar image the wreck seems to be relatively intact and no wreck debris scattered more than 50 meter away from the wreck. It does not seem to be any trawl scars close to the wreck. MMT has done a ROV

and bathymetry survey of the wreck. The ROV-pictures shows clearly that it is a wooden wreck (MMT 2016b) but the still images provided in the report is not enough for an exact dating of the wreck. The wreck seems to be carvel built with inner planking and is probably a cargo ship. The possible stern is located to the north and the bathymetry shows an

object outside the hull that could be the rudder (fig. 22). The size and shape (bathymetry) of the wreck is similar to the investigated fluit ship Jutholmsvraket from around 1700 (Eriksson 2010), but it might also be a galiot from 18–19th century, that also had similar shapes like the fluit ships. The degree of composition also indicates that the wreck is likely to

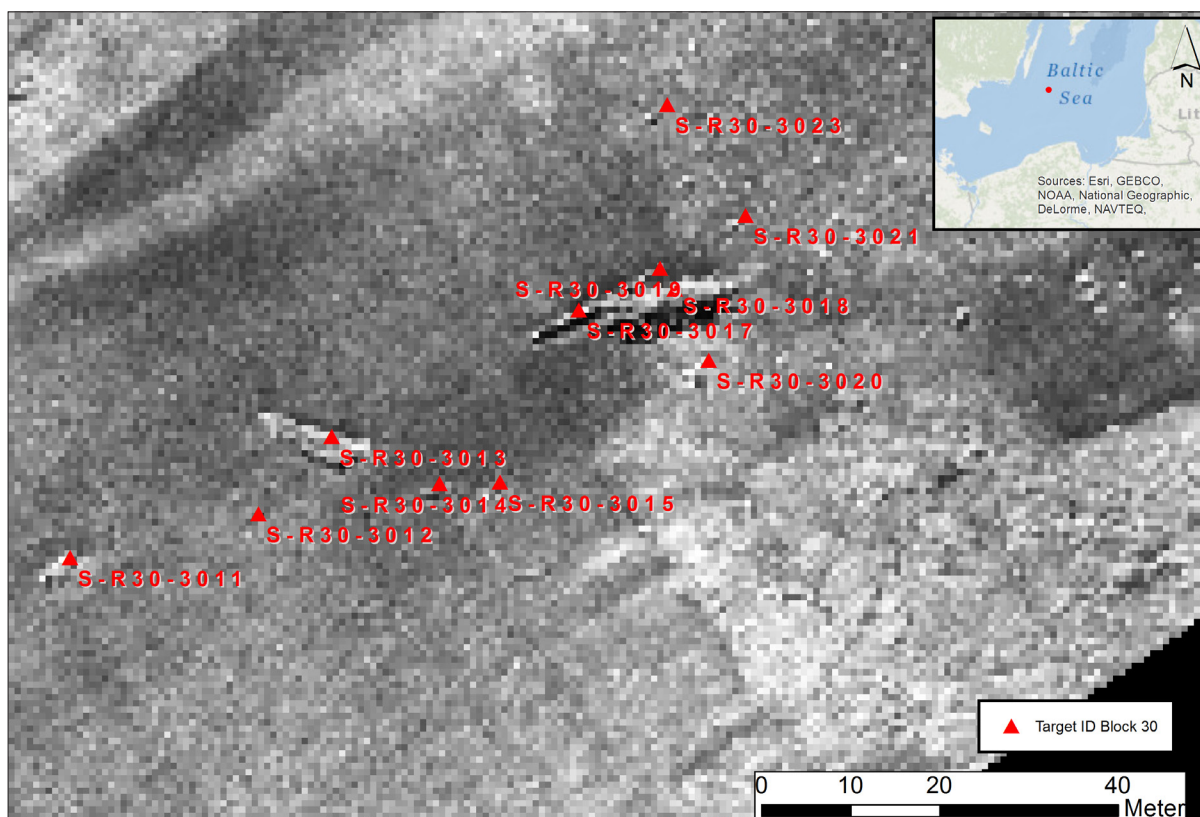
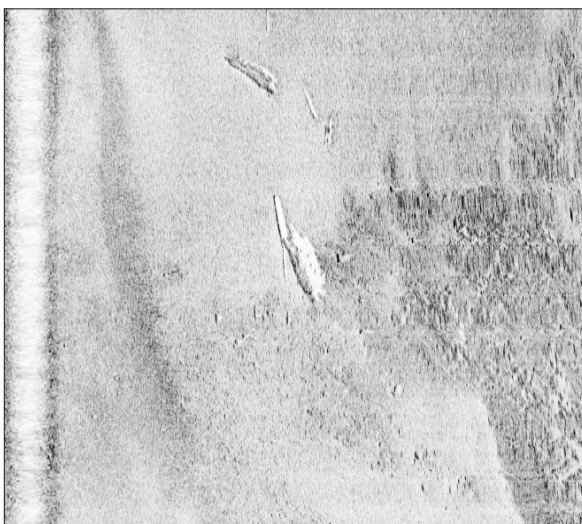
Fig 26. Sonar image of wreck S-R30-3018 and possible debris
© Fugro.

Fig 27. Sonar mosaic map over the area around wreck S-R30-3018. © ESRI and Fugro, edited by Mikael Fredholm, Maritime Museum.

A wreck area with debris S-R30-3011 to S-R30-3023. Based solely on the sonar images it is not clear if all “wreck debris” are from the same wreck. 80 meter to the northwest is indication S-R30-2737 that might be another wreck or parts of the same wreck as S-R30-3018. It could be one or more wrecks. Until the status of all the possible wreck debris is clear (i.e. ROV-inspection) SMM recommend an offset of 50 meter to each indication.

For the possible scattered wrecks like S-R30-3018 and S-R-32-0423 SMM suggest that the wrecks and the associated debris is ROV-inspected. If then the debris is concluded as not highly significant for the understanding and dating of the wrecks SMM might recommend a protected core area like for the wreck S-R31-1707 (R32- 92558 in 2010).

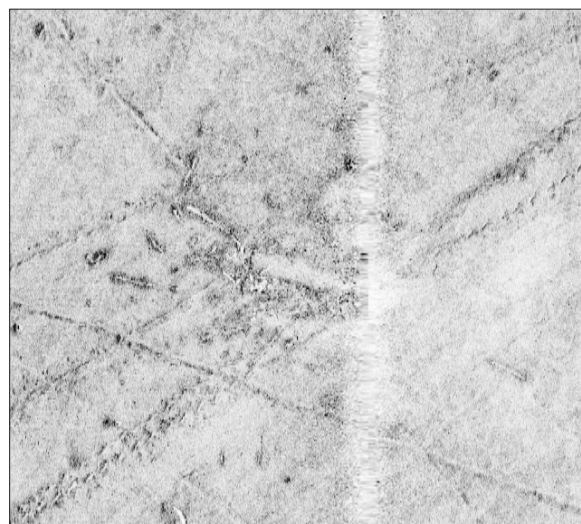
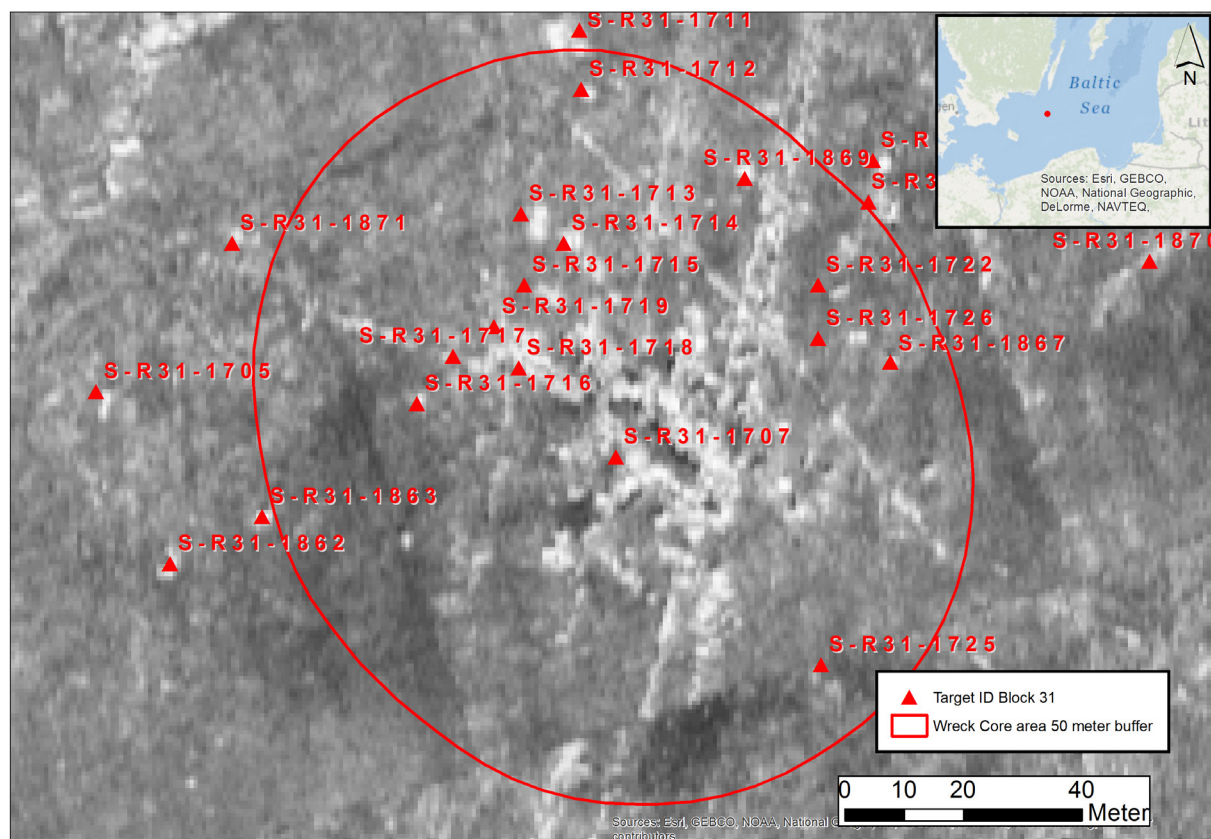
This is the wreck R32-92558 from Nord Stream (Fredholm 2010: page 29) but the wreck is now called S-R31-1707 by Fugro. Associated wreck de-

Fig. 28. Sonar image of wreck S-R31-1707 and wreck debris around the indication. There are also travel scars in the bottom.
© Fugro.

bris are S-R31-1706 to S-R31-1726 and S-R31-1862 to S-R31-1872.

The earlier ROV documentation determined that it is a carvel-built vessel of wood. The wreck

Fig. 29. Sonar mosaic map over the area around wreck S-R31-1707. Core area is the in 2010 agreed 50 meter protection area. © ESRI and Fugro, edited by Mikael Fredholm, Maritime Museum.

is degraded and has probably been damaged by trawling. It is spread over an area of approximately 140×160 meter, but the main wreckage area is about 30 meters (NW–SE) \times 15 meters (SO–NE). Among the wreckage it was possible to discern

some bottles – one could be dated to the period 1720–1750 and one to 1720–1780. The windlass has a carved wreath and is typologically dated to

18th century, same as the bottles. Everything indicates that the ship have foundered in the 18th century (Fredholm 2010: page 29). The wreck corresponds to the definitions in the Swedish Heritage Conservation Act (1988: 950) as a cultural monument. In 2010 after the ROV-inspections Nord Stream and SMM agreed to protect a 50 meter core area of the wreck S-R31-1707 (R-32-92558) as shown in fig. 29. This is now SMM's proposed offset to the pipeline.

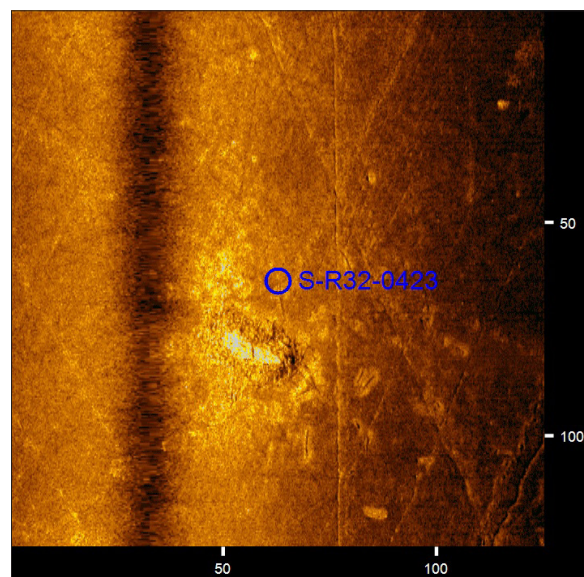
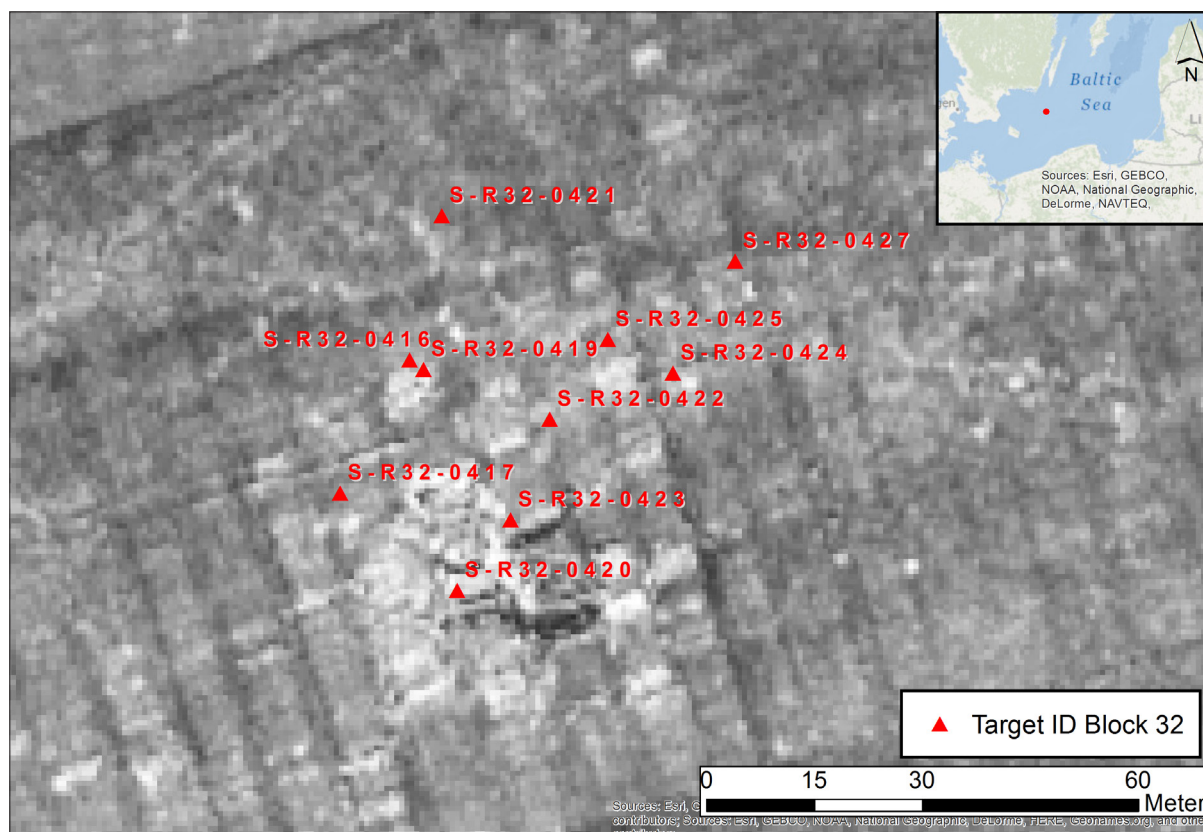
Fig. 31. Sonar image of wreck S-R32-0423 and possible wreck debris around the indication. There are also trawl scars in the bottom. © Fugro, edited by Mikael Fredholm, Maritime Museum.

Fig. 32. Map over the area around wreck S-R32-0423 and the possible wreck debris. © ESRI and Fugro, edited by Mikael Fredholm, Maritime Museum.

A wreck area with possible wreck debris S-R32-0416 to S-R32-0427 (fig. 32). Until the status of all the possible wreck debris is clear (i.e. ROV-inspection) SMM recommend an offset of 50 meter to each indication.

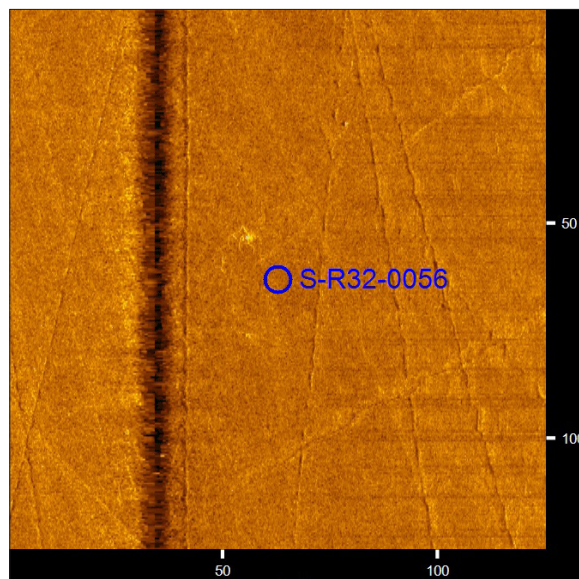
S-R32-0056

Fig. 33. Sonar image of sonar indication S-R32-0056. Around the indication there are possible trawl scars in the bottom. © Fugro.
