VRAK – MUSEUM OF WRECKS
ARKEOLOGISK RAPPORT 2019:20

NORD STREAM 2

ARCHAEOLOGICAL MONITORING OF FIVE SHIPWRECKS

BALTIC SEA
SWEDISH EEZ

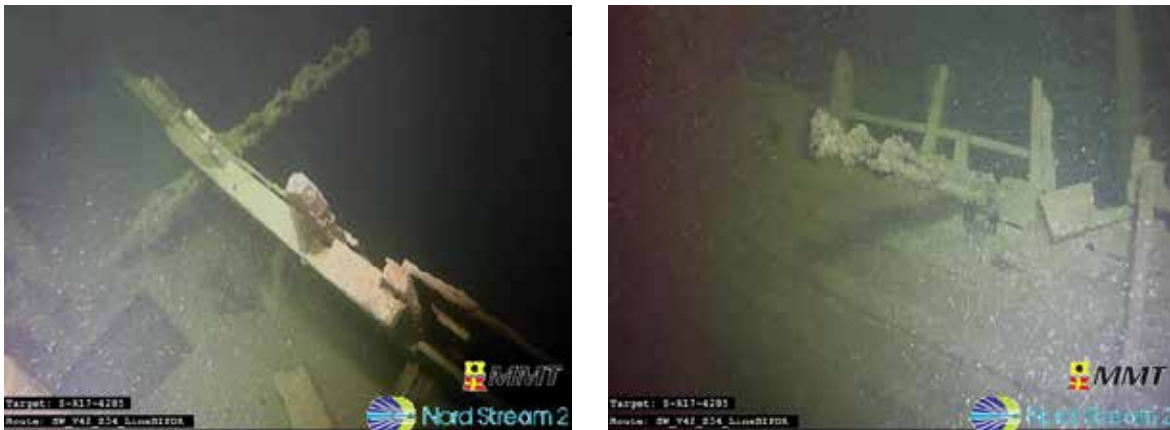
The shipwreck is undisturbed by the construction of the pipeline.

A comparison of the multibeam-images from the prelay-inspection and the postlay-inspection shows no signs of changes on the wreck and the surrounding seabed. The ROV-inspection confirms that the ten objects (A-J) "events" and the wreck are unchanged.

FIGURE 2. Photos on the possible swivel gun on the starboard side. Pre-construction (Event A). Photo: MMT/Nord Stream 2.

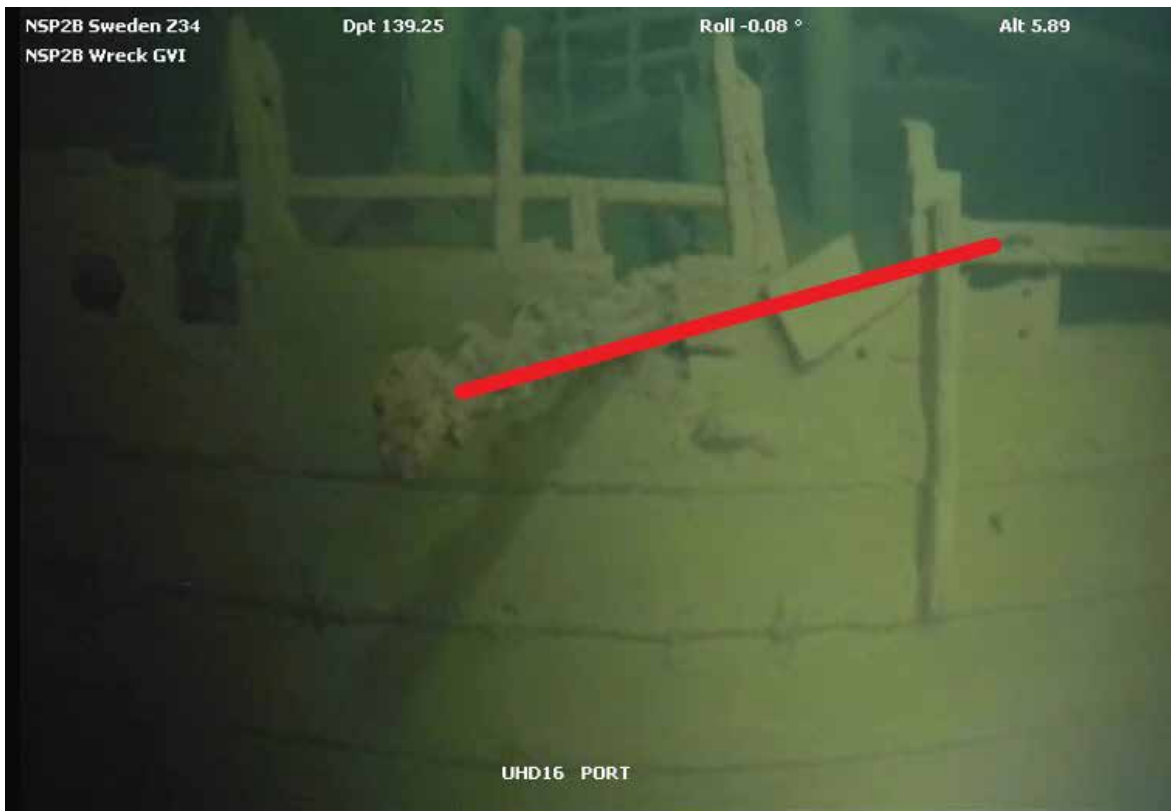
to the one at *Bodekull*. If the possible cannon isn't a cannon, it might be a beam for the sails (Ali 2019).

FIGURE 3. Photos on the possible swivel gun/beam (left) and a pulley (right) on the starboard side. Post-construction (Event A). Photo: Allseas.

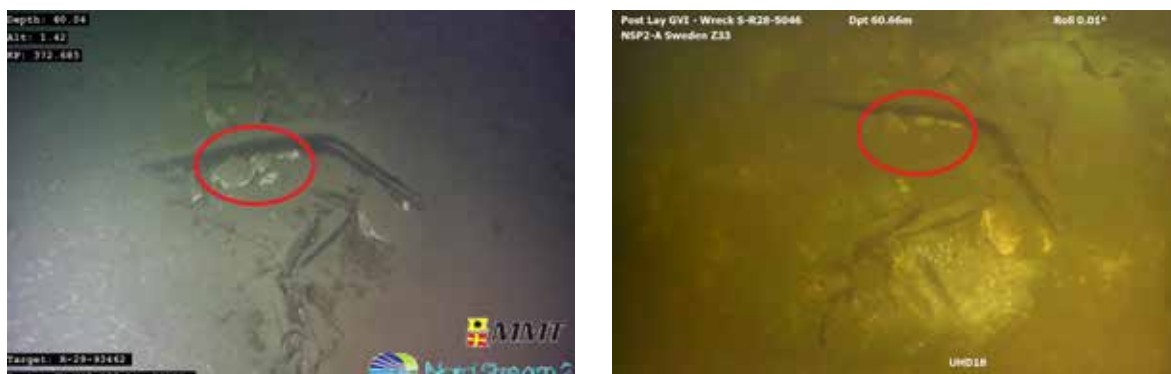
As seen from earlier inspections, the sedimentation seems to vary on this site (Fredholm 2019:26). For example event A; a ship timber and stones seems to have different sedimentation on the postlay-inspection. The sediments on the sea bottom and the wreck seems to be volatile and light. Therefore the sedimentation seems to change from time to time. The wreck as a whole does look unchanged between 2009 and the postlay-inspection 2019.

FIGURE 4. Event A. Photos of ship timber and stones. Pre-construction (left) and post lay (right). Some of the stones seems to be more covered by sediments post-lay than pre-lay. Photo: Allseas and MMT/Nord Stream 2.

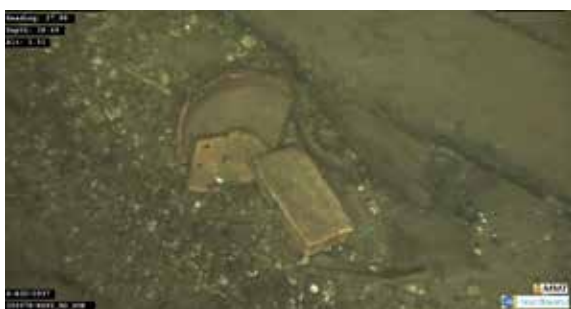
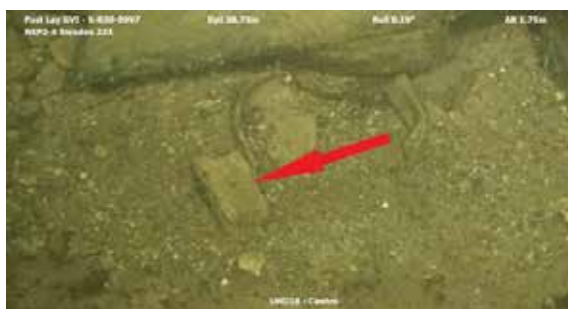
Event A: a brick has moved around 20 cm.

FIGURE 5. Event A, where a brick has moved around 20 cm. Pre-construction (left) and post lay (right). Photo: Allseas and MMT/Nord Stream 2.

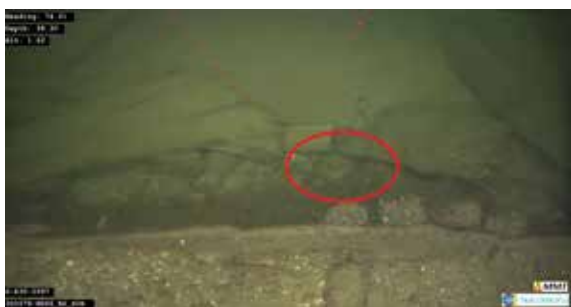
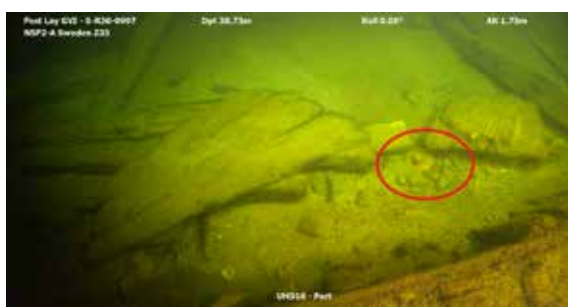
Event B, possible lid pot, a wooden object has

moved according to Allseas. SMTM has hard to see any movement, maybe it’s only a few cm.

FIGURE 6. Event B, possible lid pot, where a wooden object might have moved a few cm. Pre-construction (left) and post lay (right). Photo: Allseas and MMT/Nord Stream 2.

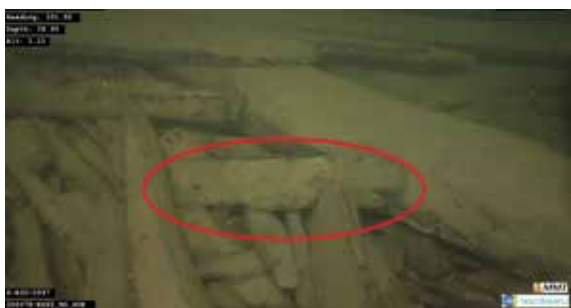
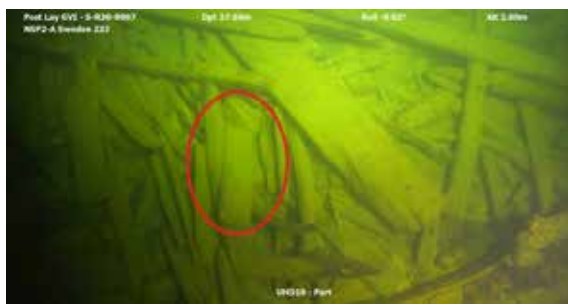
Event H, a block and planks has moved and it’s possible that the plank has moved the block slightly.

FIGURE 7. Event H; a block, where a plank has moved. Pre-construction (left) and post lay (right). Photo: Allseas and MMT/Nord Stream 2.
