SJÖHISTORISKA MUSEET  
ARKEOLOGISK RAPPORT NR 2019:5

# Nord Stream 2

Archaeological analysis of ROV-films

Baltic Sea, Swedish EEZ

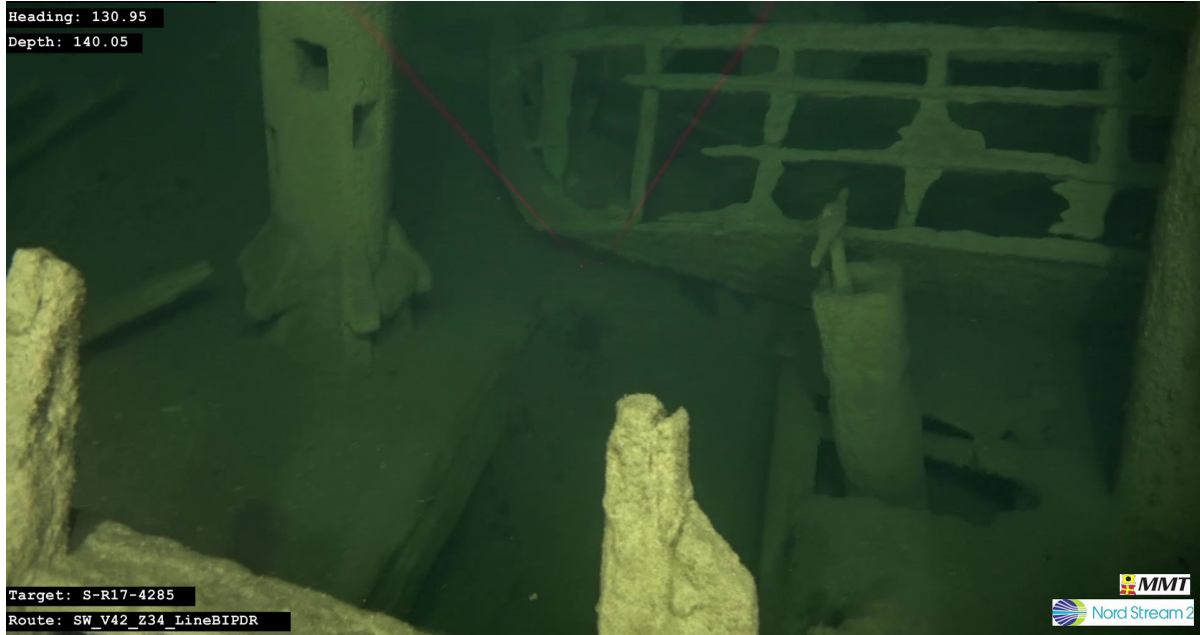
**FIG. 2.** Photo from the starboard side. From the left: the capstan, the flat-bottomed ships boat, the bilge pump and to the right end the main mast. Photo: MMT/Nord Stream 2.

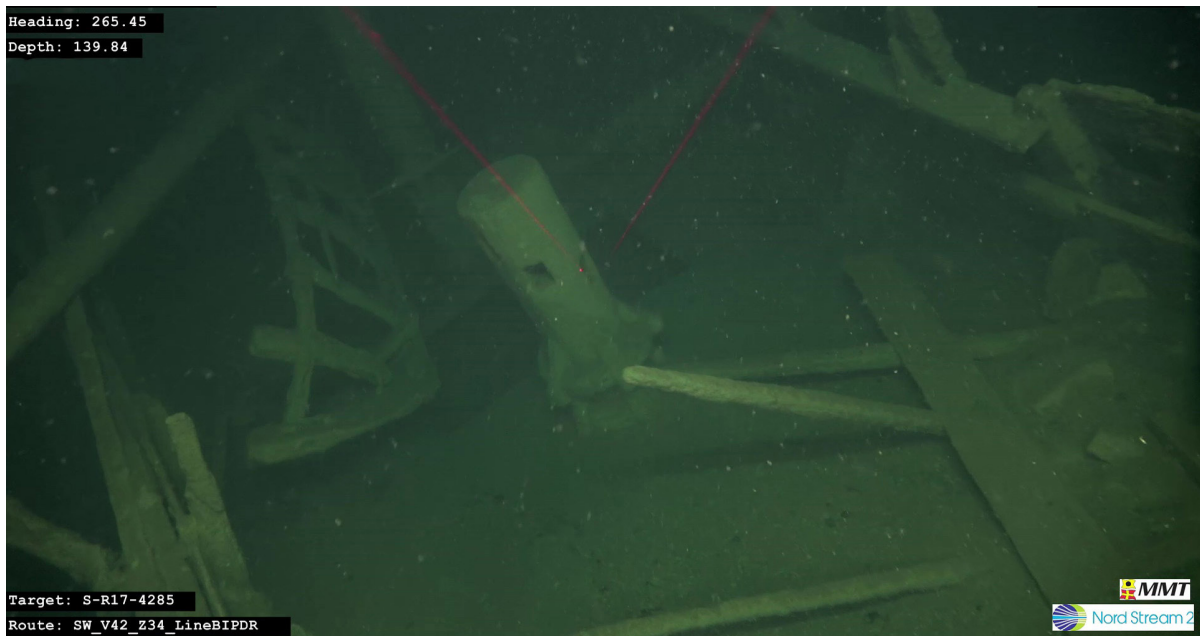
**FIG. 3.** Photo from the stern. From the left: the flat-bottomed ships boat, the bilge pump, the main mast and the capstan (Event G). Photo: MMT/Nord Stream 2.

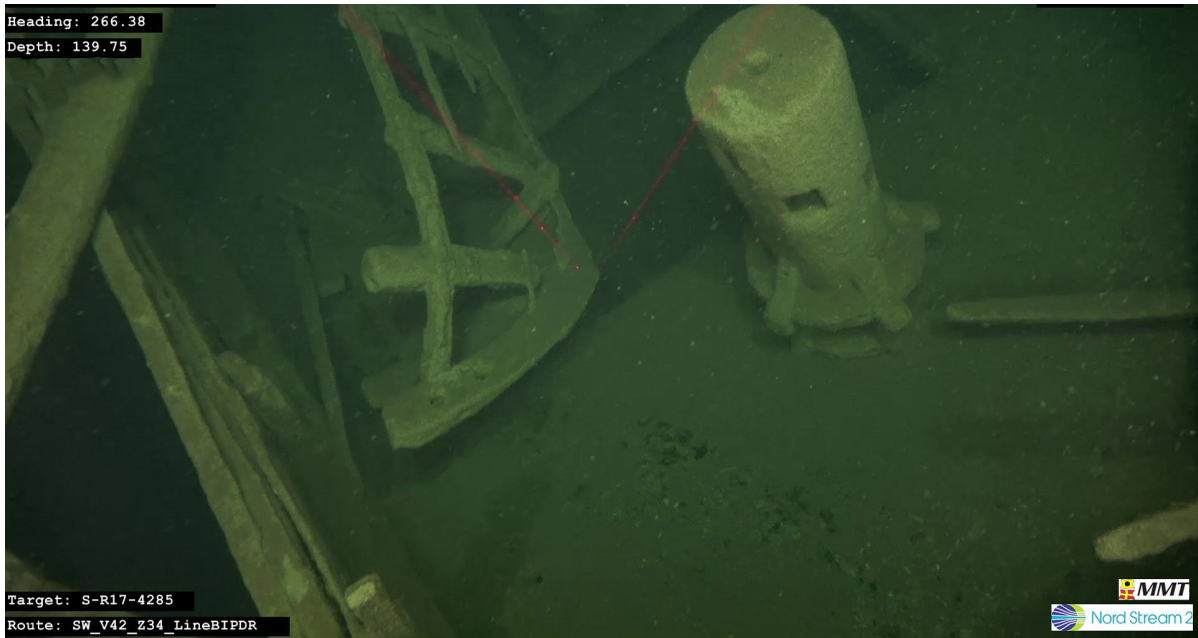
FIG. 4. The flat-bottomed ships boat and the capstan (Event G). Photo: MMT/Nord Stream 2.

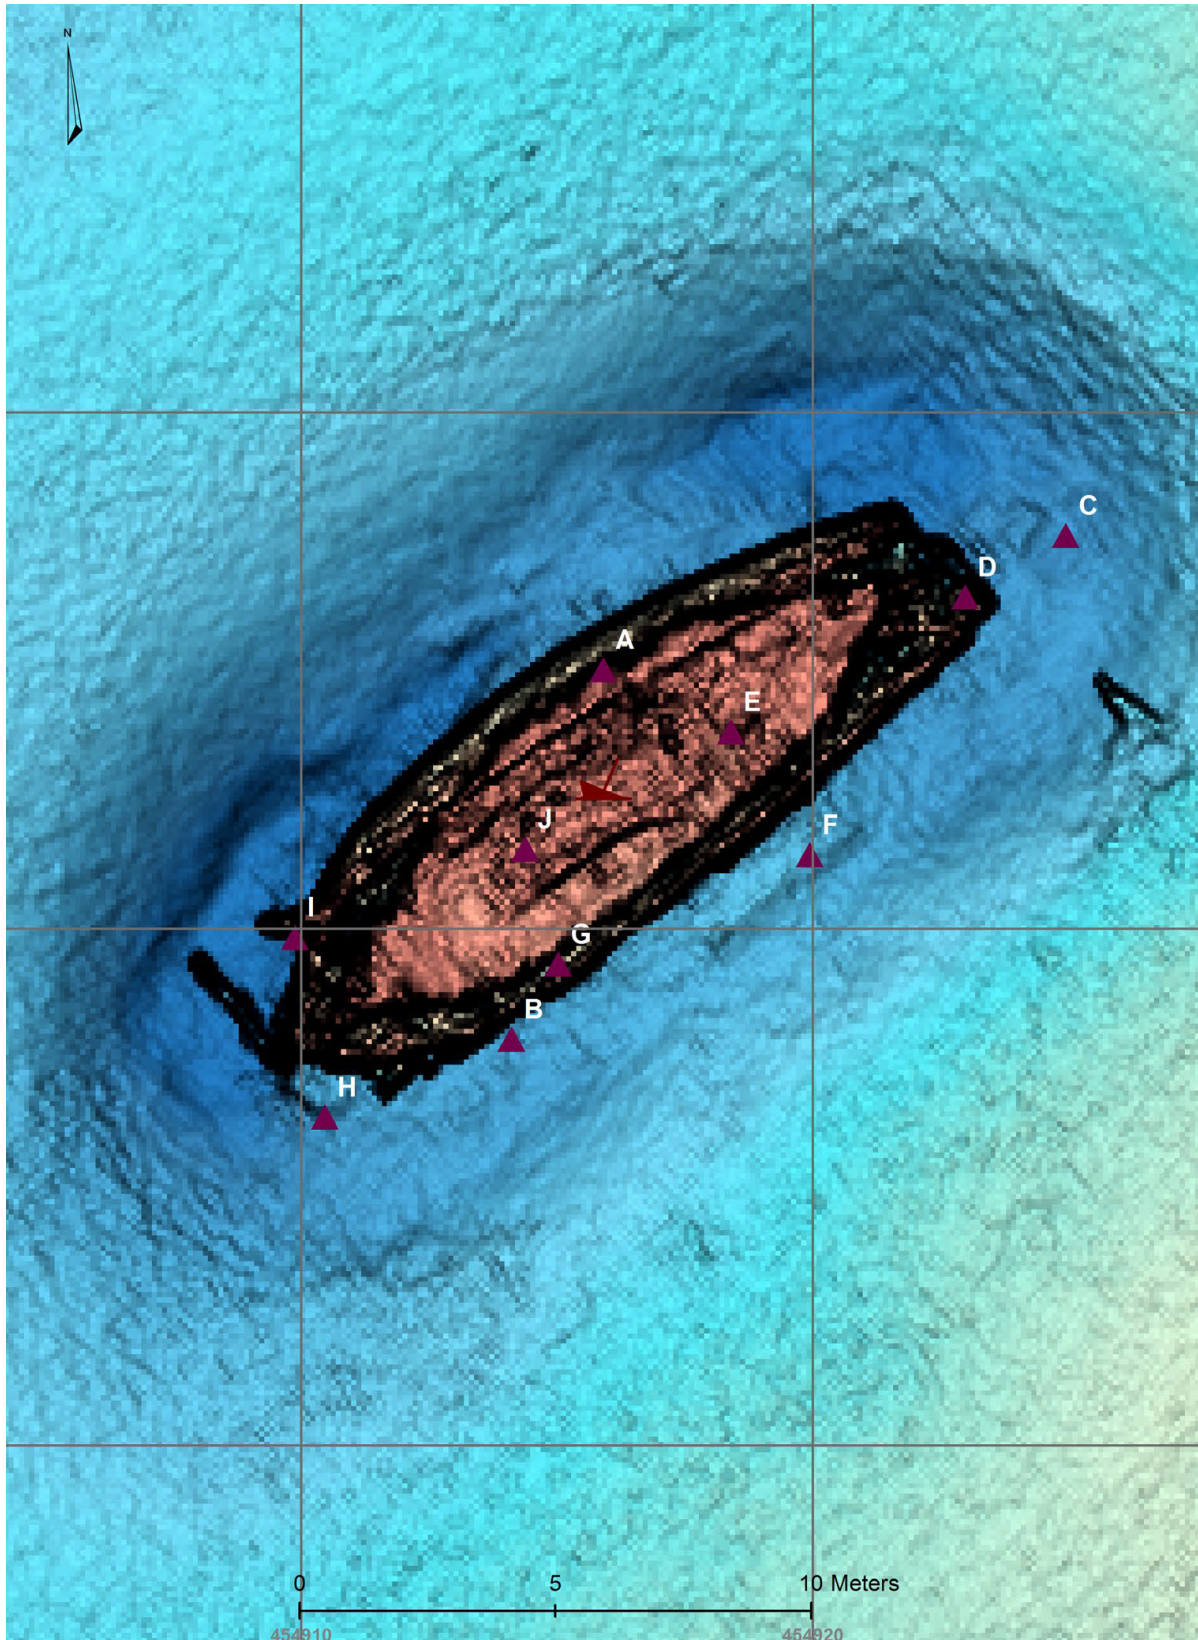
This is a wooden wreck that is 17 meters long and 5 meters wide. Based on the details and construction SMTM estimate that it has sunk before 1850, and therefore the shipwreck is to be considered an ancient monument. The construction, anchor, ships boat, capstan, details etc. indicates a 17th or an 18th century date.

**FIG. 9.** Multibeam image of wreck S-R17-4285. MMT Events A-J. A: Beam and railing of the wreck (starboard), B: Possible rigging nail, C: Wooden drawer or part of the cargo, D: Wooden debris, E: Winch (Capstan), F: Top of main mast, G: Lifeboat (Ships boat) on deck, H: Bow of wreck (portside), I: Anchor (Bow starboard), J: Possibly a cargo hatch. MMT/Nord Stream 2.

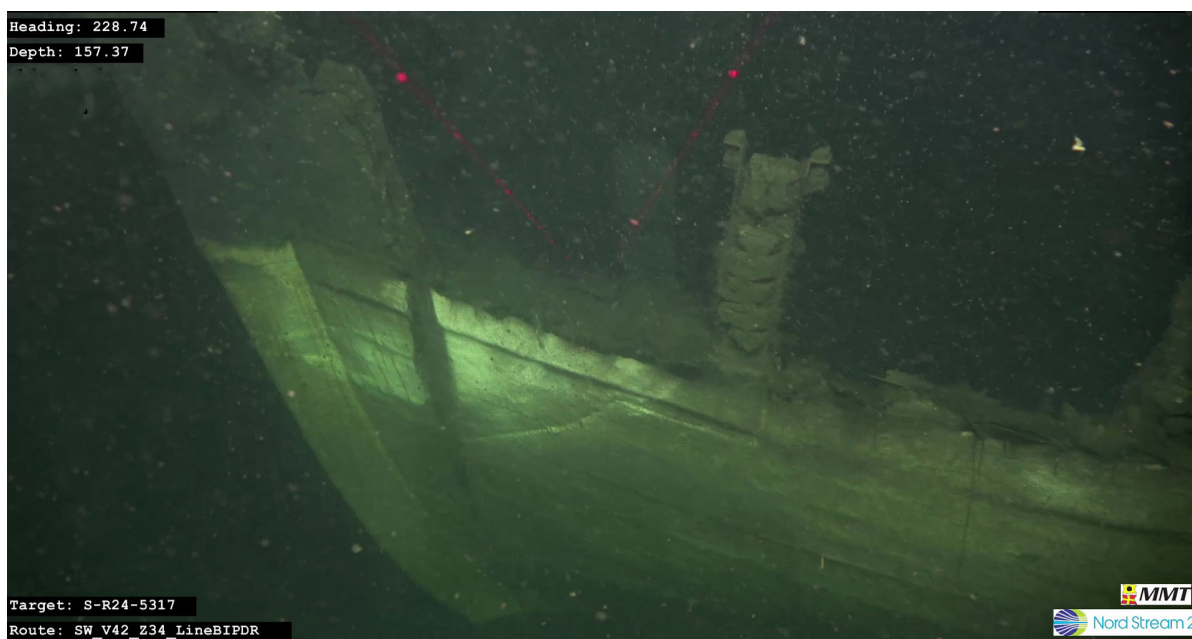
This is a wooden wreck that is 17 meters long and 7 meters wide. The bridge is built of metal and the hull seems to be white painted or plastic coated.

**FIG. 10.** Port side of the bow. The painted/plastic coated hull is clearly visible. Photo: MMT/Nord Stream 2.

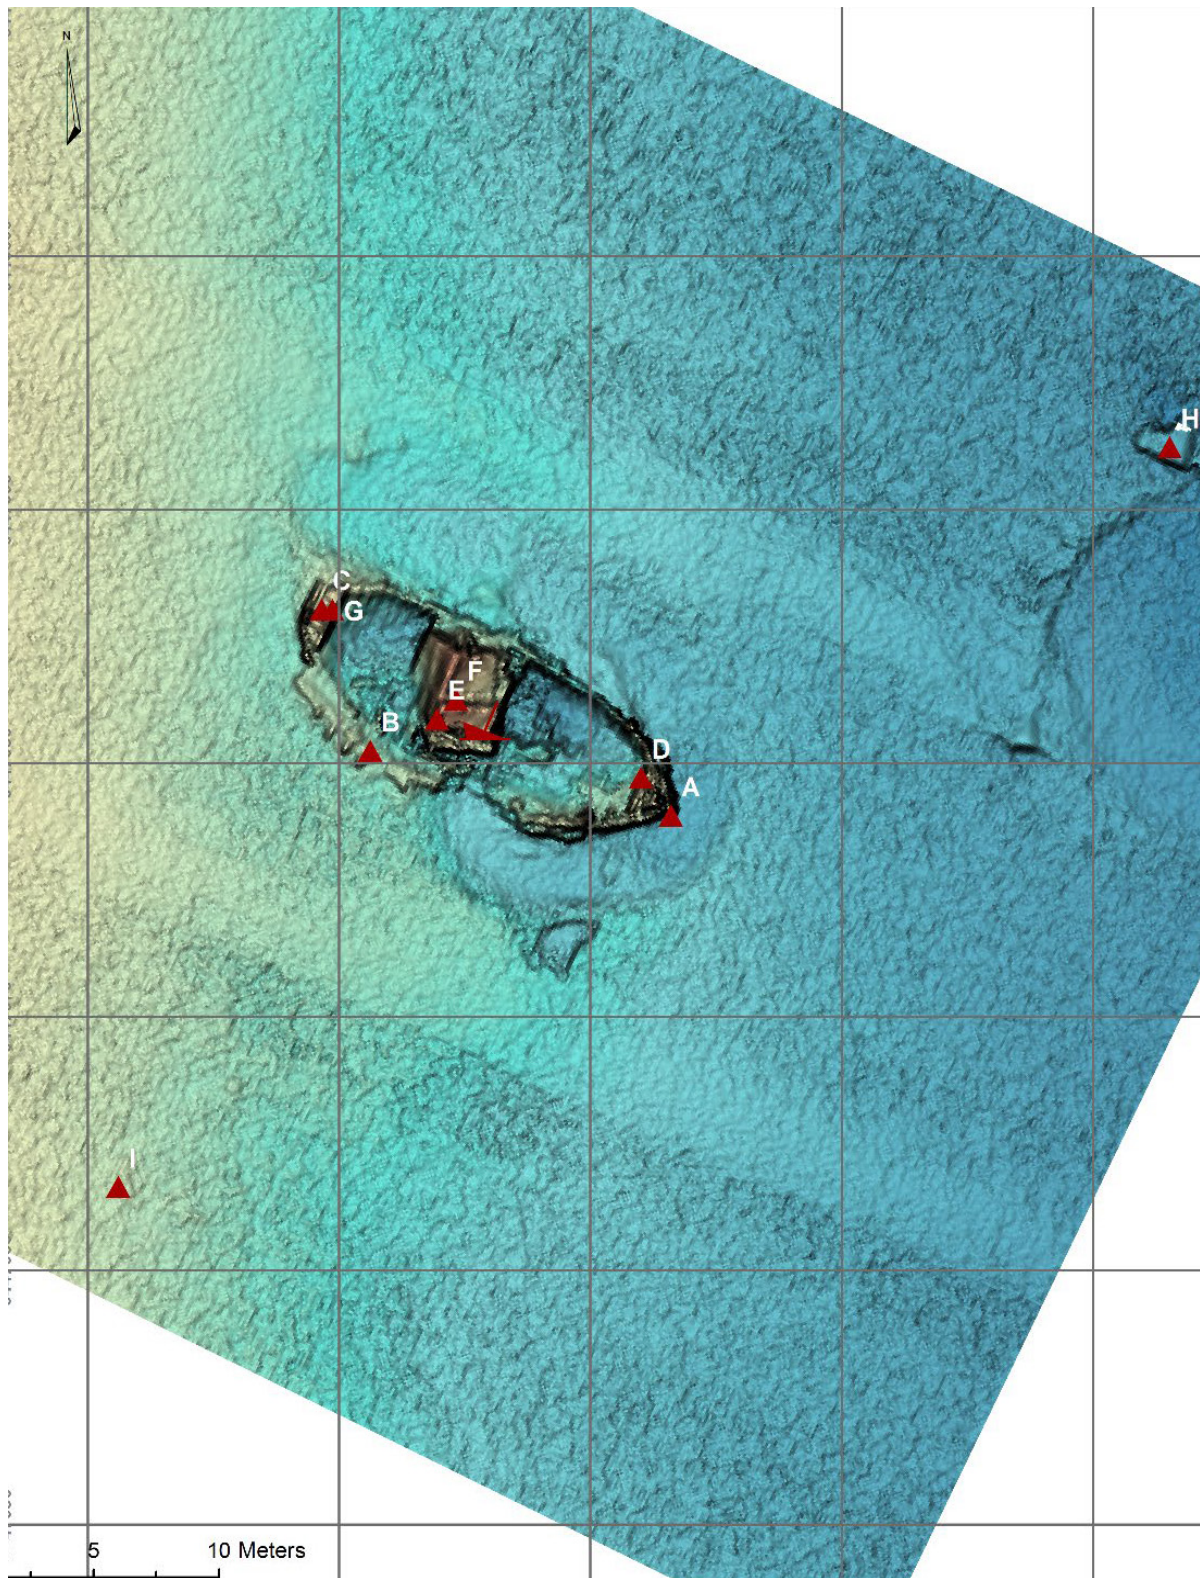
**FIG. 12.** Multibeam image of wreck S-R19-1026. MMT Events A-J. A: Bow of the wreck  
 B: Container, C: Stern of the wreck, D: View of the bow, E: Bridge and the navigation light, F: Steel ladder, G: View of the stern, H: Concrete, I: Wooden beam. MMT/Nord Stream 2.

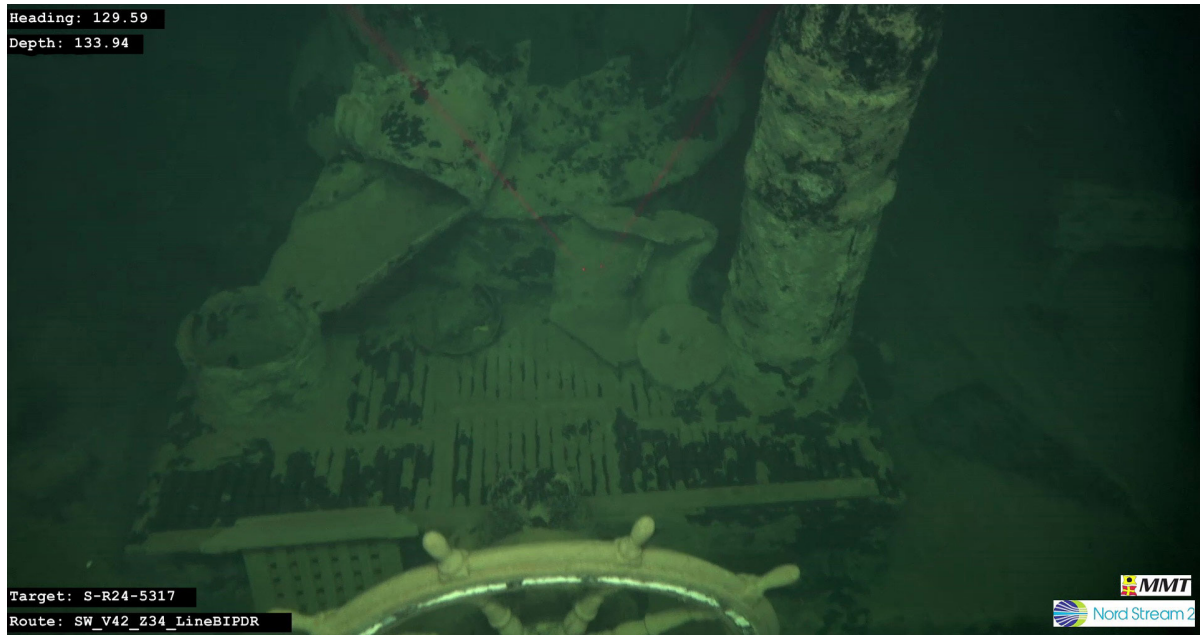
On the new ROV-films a chimney, steering wheel, a machine telegraph, navigation light etc. is visible (Fig. 13-15). In the stern (Fig. 19) the construction indicates that the ship had a propeller, there are remains of a rudder post and propeller post. In the bow there is a figure head and a bowsprit (Fig. 16). So it's now clear that it was a sailing ship that was fitted with an (steam) engine, possible both for propulsion and for the many winches on deck.

FIG. 13. The chimney and steering wheel (Event O and J). Photo: MMT/Nord Stream 2.

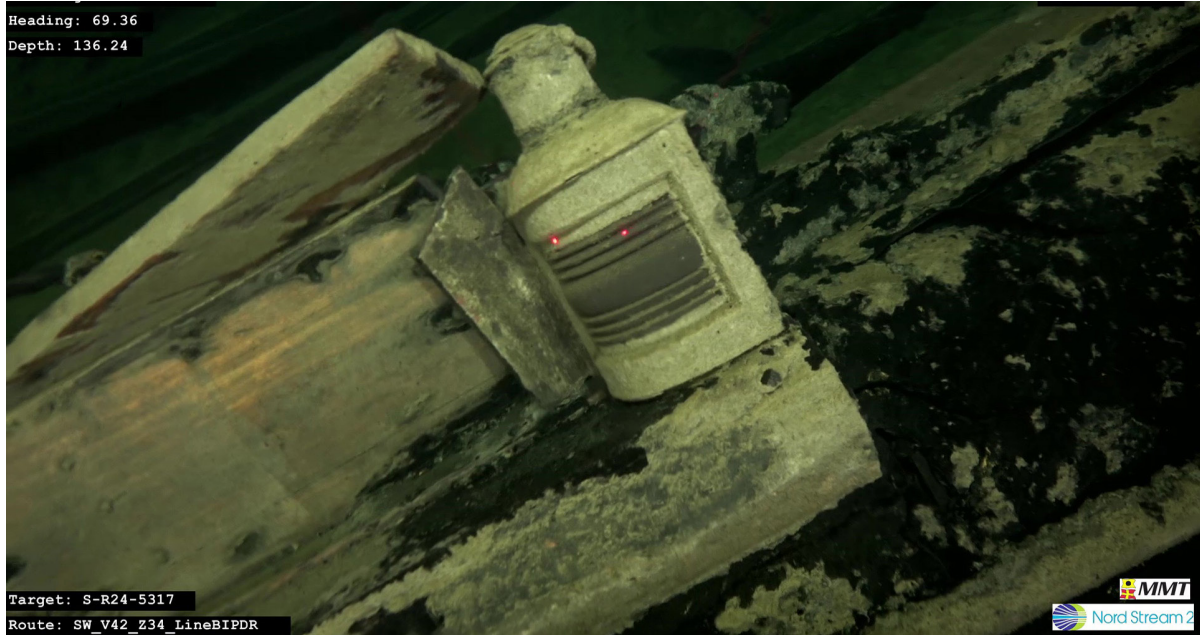
The type of lanterns (fig. 15) might be from 19th or the early 20th century. Similar shaped lanterns was in use during the first half of the 20th century (see for example; Kihlberg 1978:65).

**FIG. 15.** Port navigation light (Event P). Photo: MMT/Nord Stream 2.

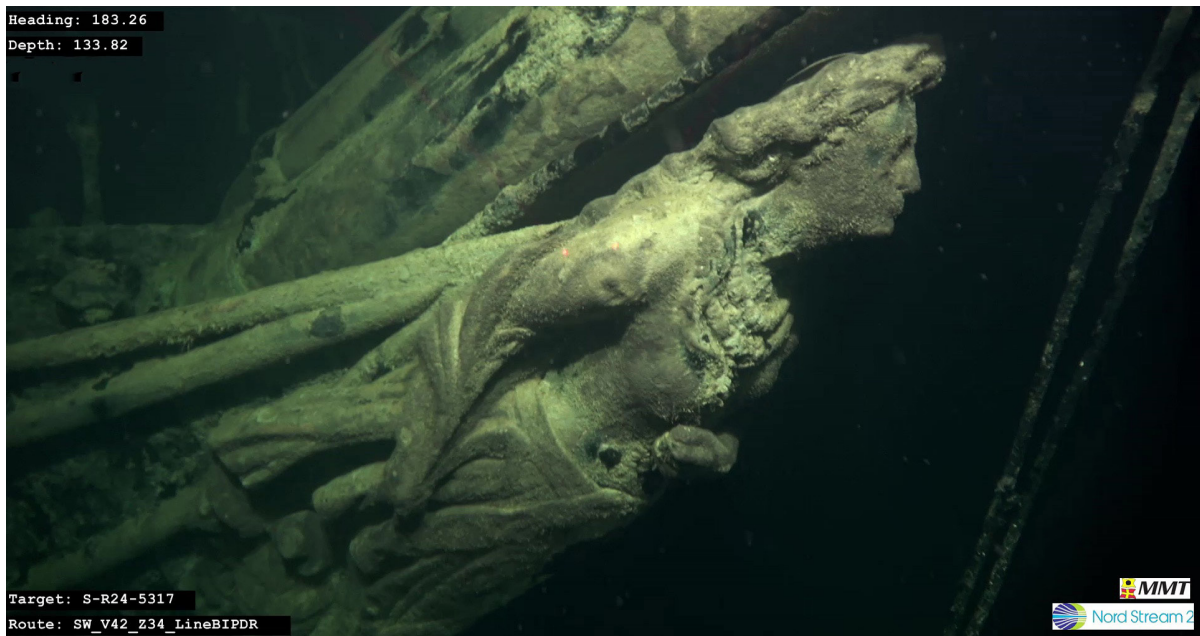
The hull is made of steel plates as well as deckhouses and the forecastle, where a wooden deck is visible. On the forecastle deck there are winches with steel cables and anchors with davits. The wreck has a "Clipper-shaped" bow (see cover image) with a figurehead in the shape of a

woman (fig. 16). The deck is at least partly suspended by steel beams.

The figure head indicates a dating to around 1880-1890, as these types of figureheads later became smaller on bark ships (Hedlund 2019).

**FIG. 16.** The figurehead in the bow (Event B). Photo: MMT/Nord Stream 2.

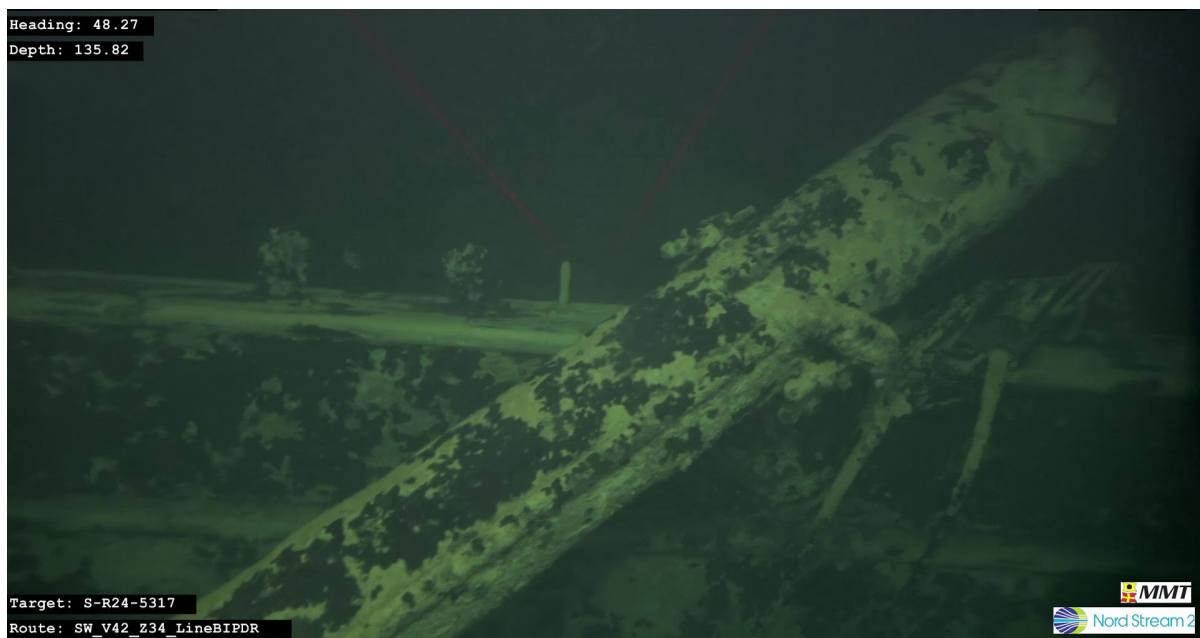
There are collapsed masts and rigging details lying on the wreck and on the seafloor, especially on the port side close to the bow. There is a ten meter high rest of a standing mast forward of the life boat and ladder on deck (event H-I), close to a deckhouse in the aft part of the wreck. The wreck has three lifeboats, one upside down on the starboard side outside the wreck and one hanging on the starboard side. This type of lifeboat can either be from the 19th or the early 20th century.

**FIG. 18.** A part of a mast hanging over the port side, close to the bow. There is also a pin rail with nails for the ropes in the rigging. Photo: MMT/Nord Stream 2.

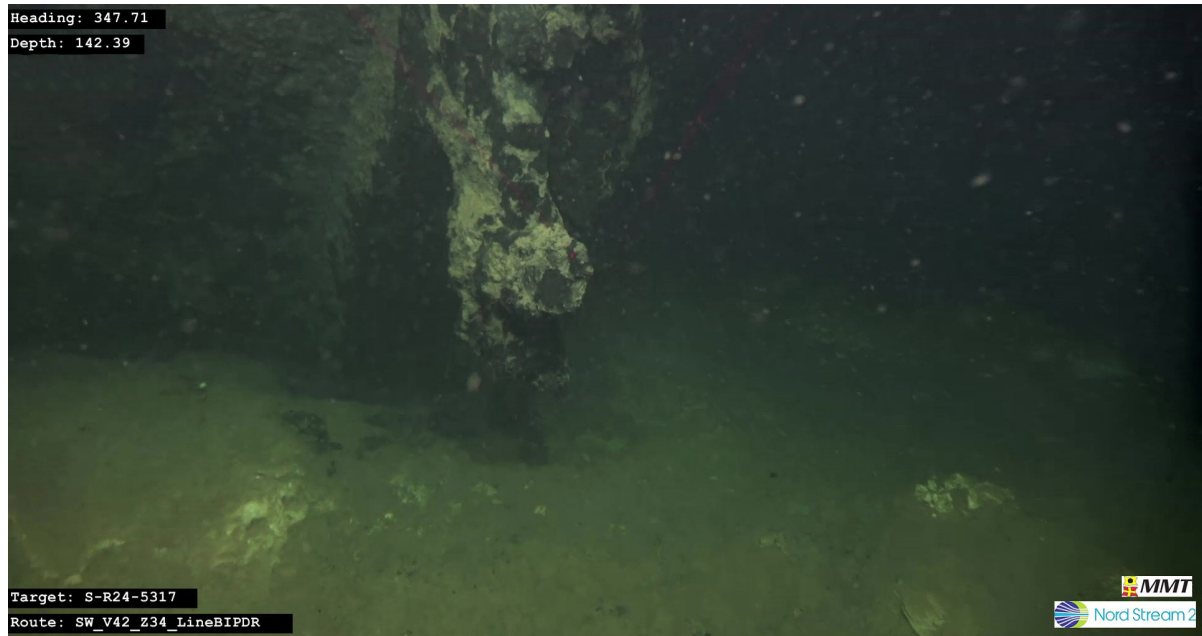
**FIG. 19.** The remains of a rudder post and propeller post. Photo: MMT/Nord Stream 2.

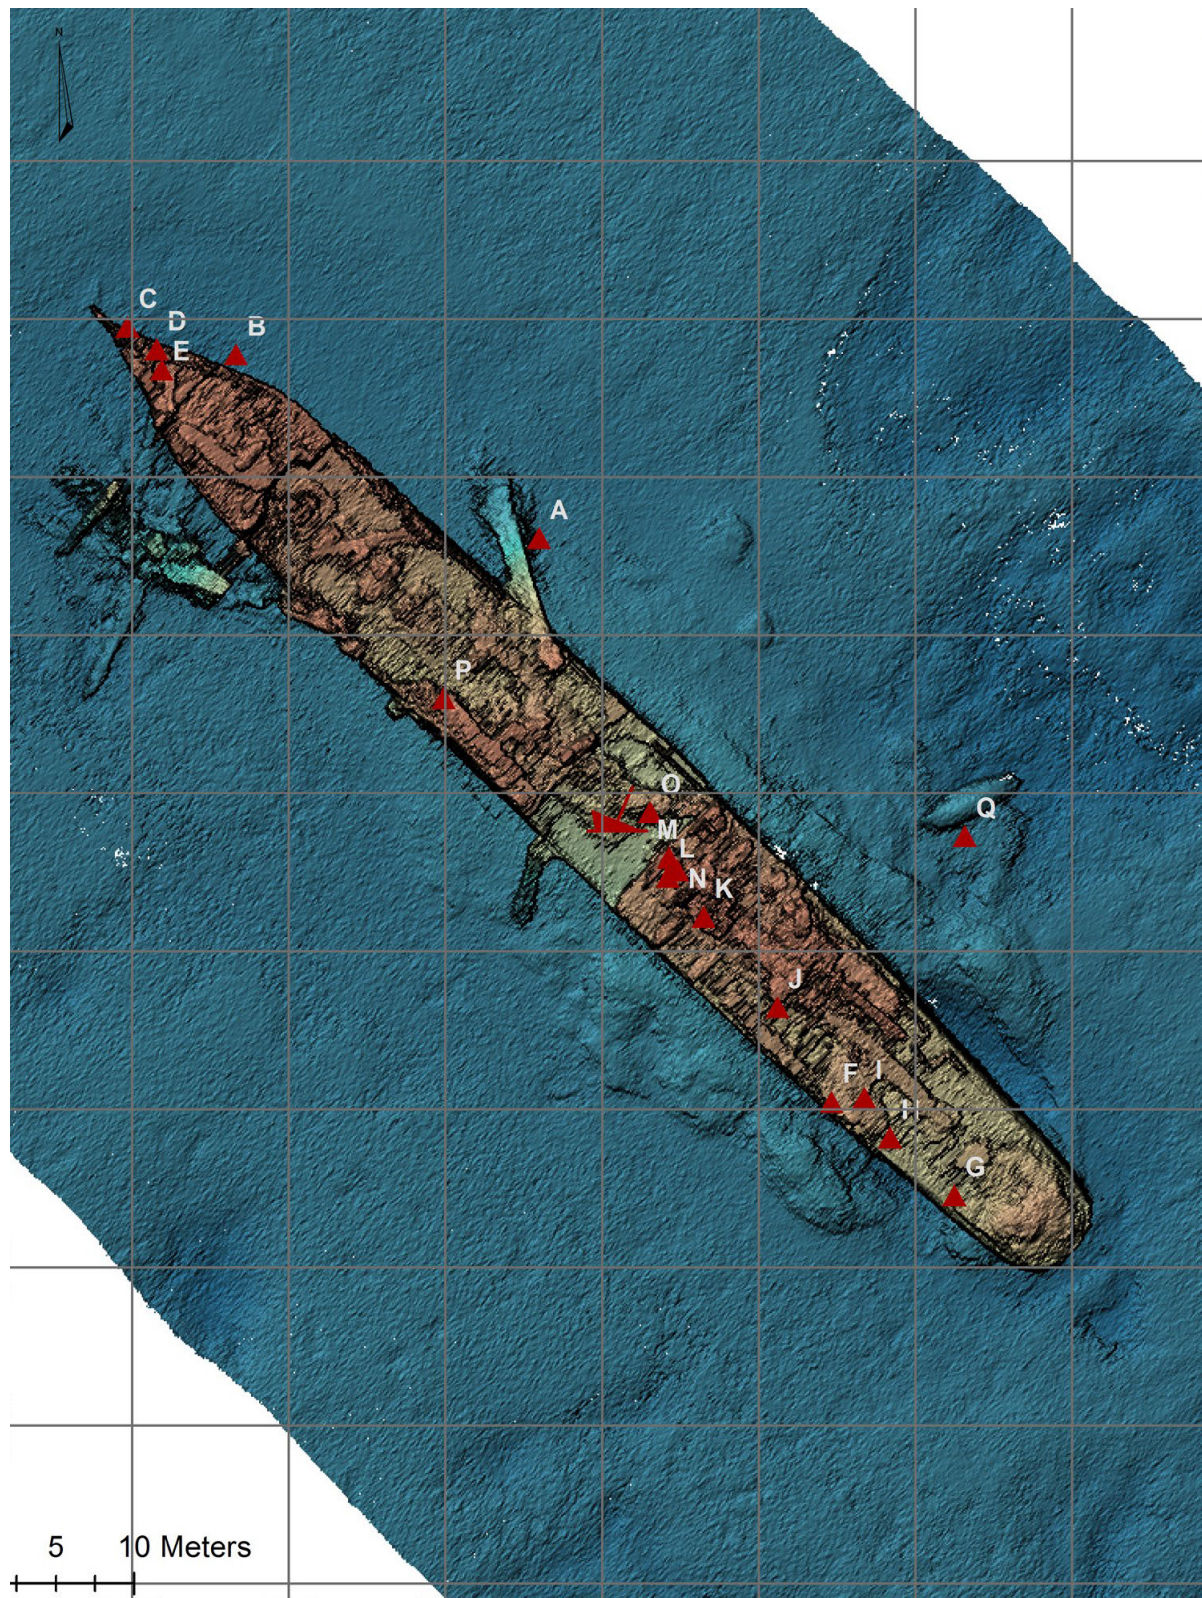
**FIG. 20.** Multi-beam image of wreck S-R24-5317. MMT "Events A-Q. A: Collapsed mast of the wreck, B: Figurehead, C: Anchor on the main deck, D: Bow of the wreck, E: Main deck of the shipwreck, F: Debris item, a cup, G: Port hole, H: Wooden ladder, I:Upside down life boat on the main deck of the wreck, J: Part of a chimney, K: Steel frame windows, L: Ship's bell, M: Compass, N: Davit (Machine telegraph) , O: Wooden steering wheel, P: Port navigation light, Q: Upside down life boat to the starboard side of the wreck. MMT/Nord Stream 2.

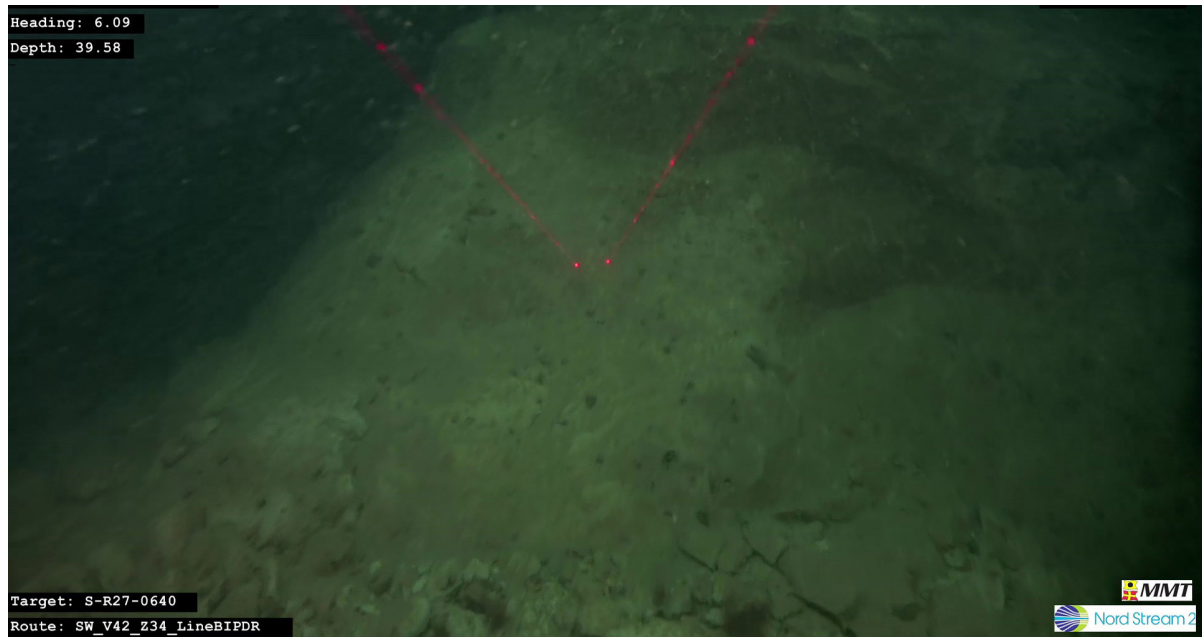
The objects are natural formations, rock outcrops.

**FIG. 21.** Rock outcrop S-R27-0640. Photo: MMT/Nord Stream 2.

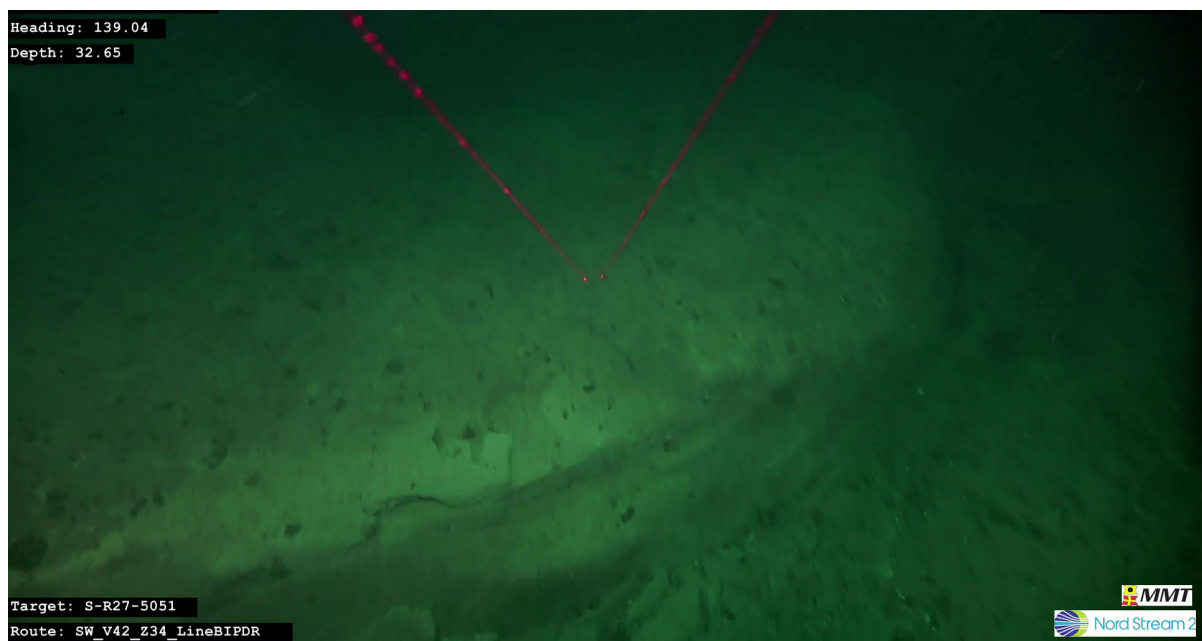
**FIG. 22.** Rock outcrop S-R27-5051. Photo: MMT/Nord Stream 2.

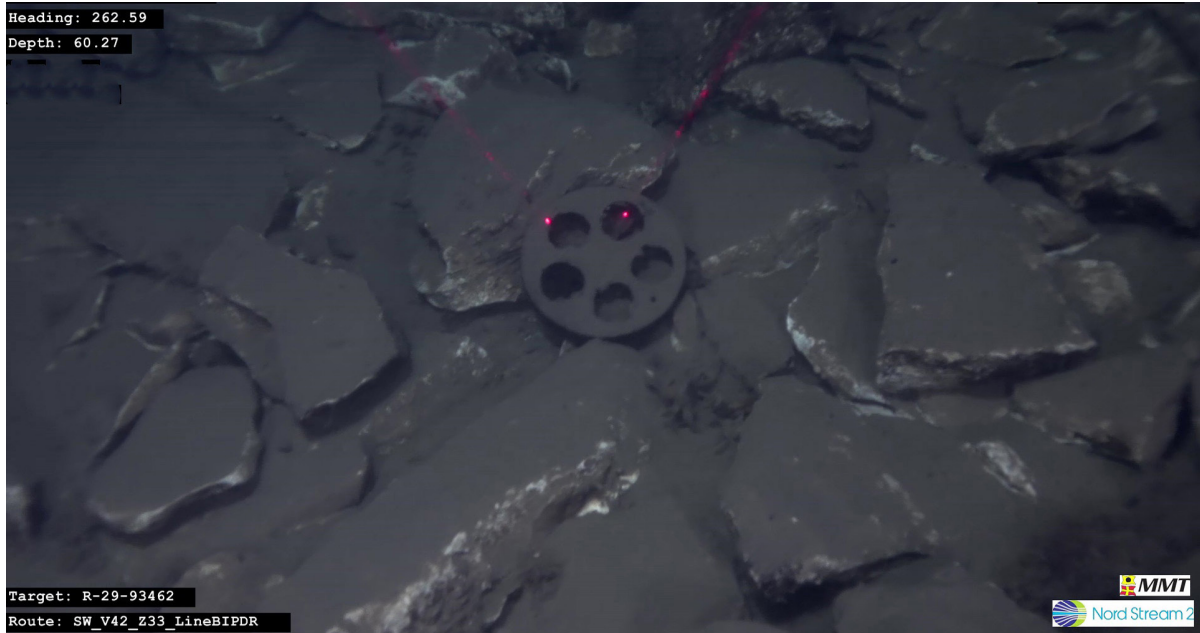
An unknown circular object, a small wheel (Fig. 23, diameter approx. 20 cm) was filmed by ROV 2019. This object was not noticed during the first surveys in 2009. The wheel seems to be of a more modern type (probably metal) than the wreck itself. So it might have been dropped on the site after 2009 (probably after 2012), or maybe sediments have moved since 2009/2012, so it has been visible. The sedimentation between 2009, 2012 and 2019 differs in some way. In the 2019 inspection a thin dark sediment lies on the wreck and lime stones, and some parts of the wreck seems to have less sediment. Why is unclear, if it's part of a natural cycle or not SMTM can't judge.

**FIG. 23.** The cargo or ballast stones and an unknown small wheel (MMT event F) was filmed by ROV 2019. Photo: MMT/ Nord Stream 2.

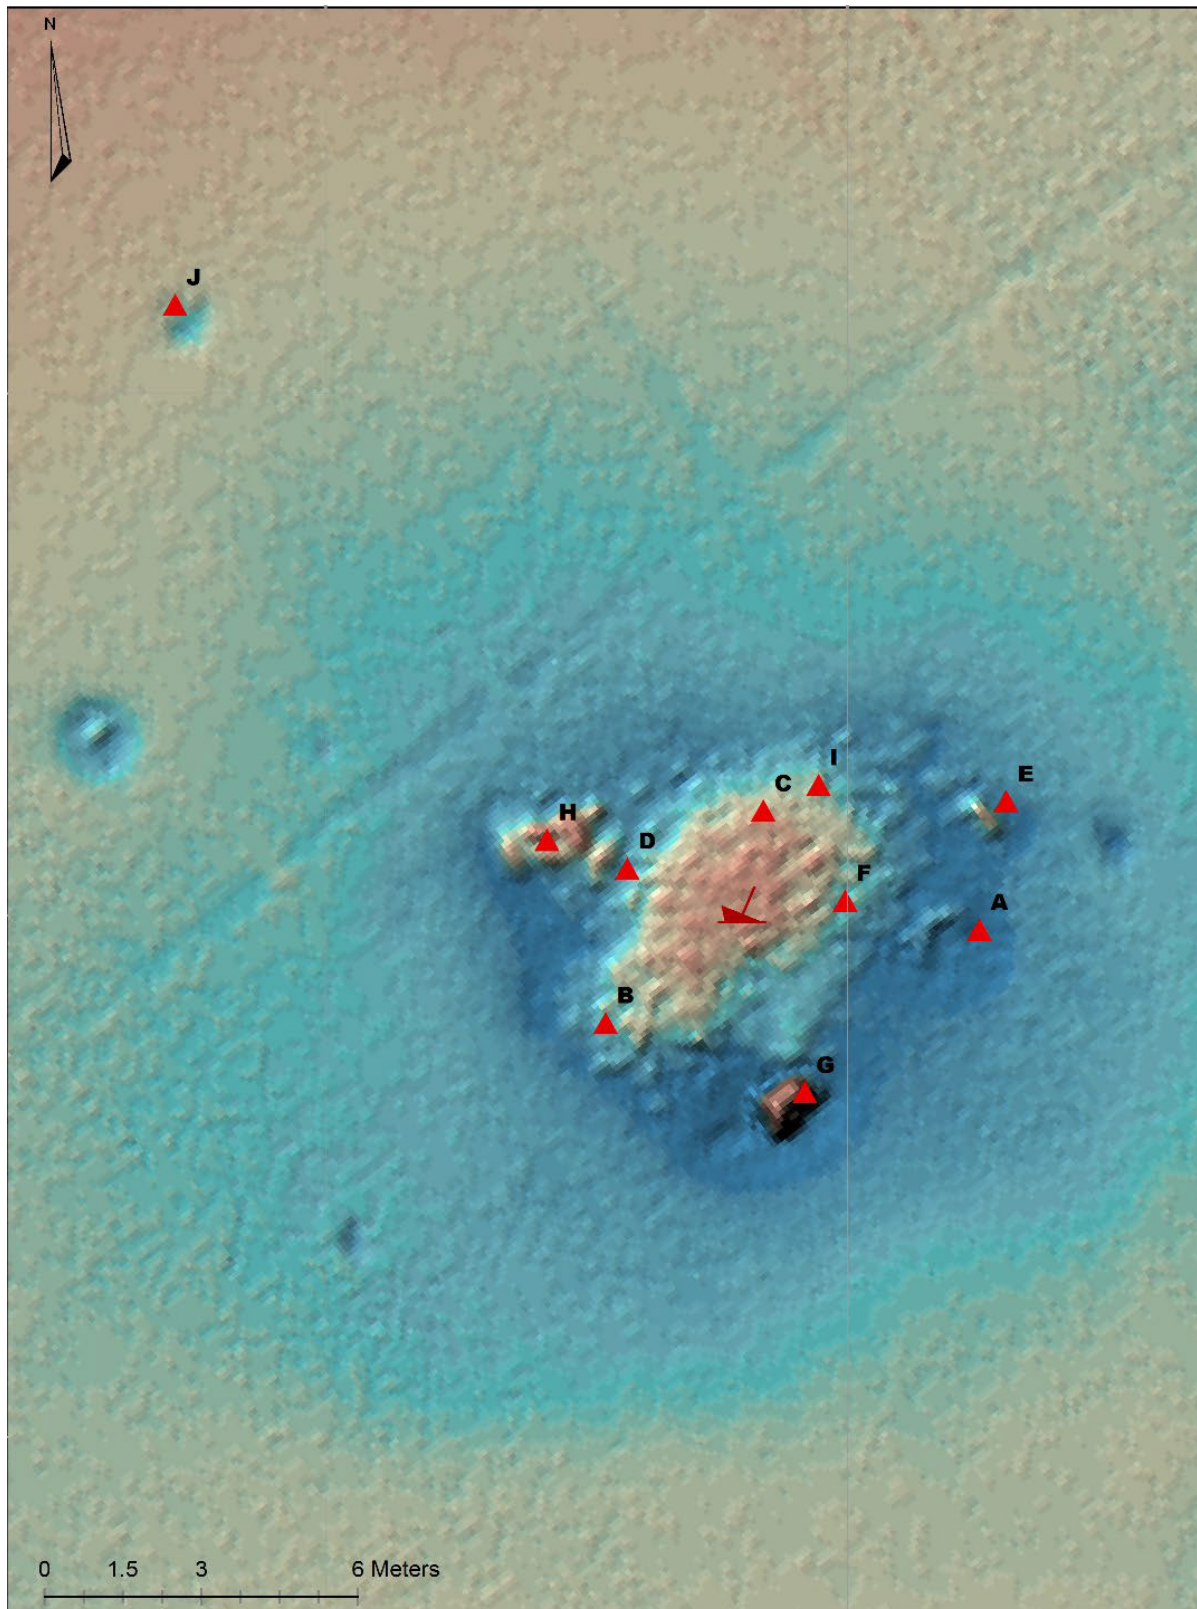
The first inspection took place in December 2009 (Fredholm 2010:27), just over nine years before this last inspection in January 2019. On the ROV-inspection 2012 after the construction of Nord Stream it was also noticed that the sedimentation was different than 2009, but the wreck itself was unchanged since 2009 (Fredholm 2013:13). The wreck as a whole does looks unchanged between 2009 and 2019.

**FIG. 24.** Multibeam image of wreck S-R28-5046/S-R-29-93462. MMT "Events A-J. A: Wooden detail, B: Wooden detail and ballast stone, C: Ballast stones, D: Probably part of the cargo on top of ballast stone, E: Possible container (Barrel) that belonging to the cargo, F: Unknown circular item, G: Possibly part of the cargo, H: Few barrel shape objects, I: Wooden detail and ballast stones, J: Elongated wooden part that related to wreck. MMT/Nord Stream 2.

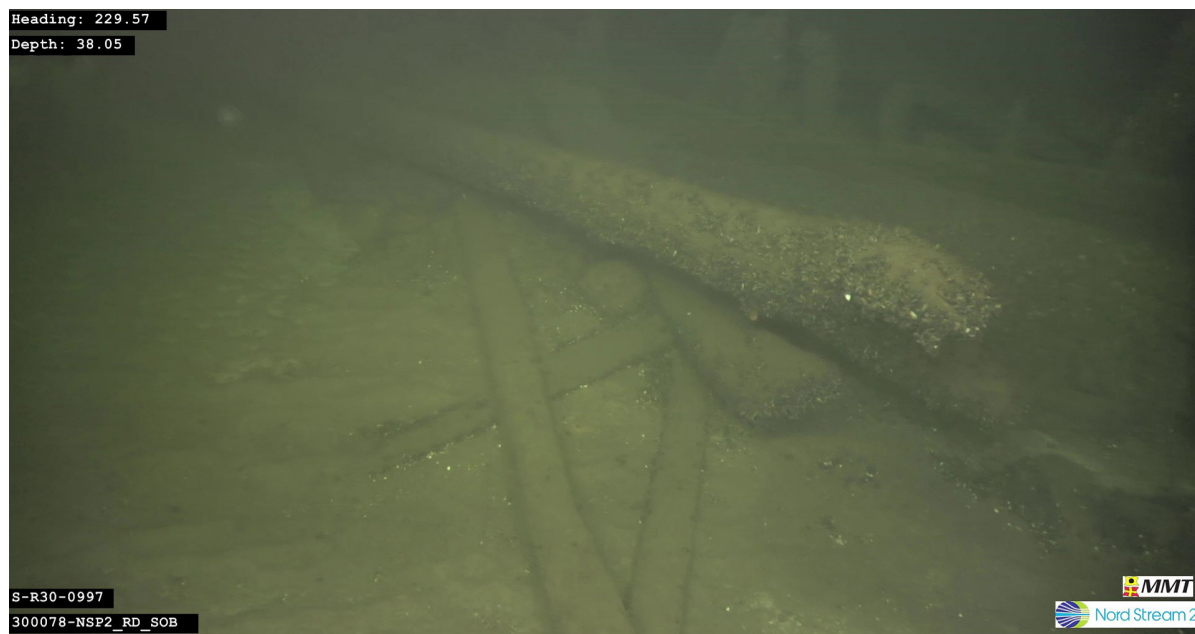
loose ship timbers, frames, planking and some blocks. Outside the wreck on the starboard side there is a gaff beam (“forked boom”, fig. 25, event D). Pictures of gaff-rigged sails appears in the mid-17th century and in the 18th century it became more common with gaff-rigged sail (Kihlberg 1963:98)

**FIG. 25.** Gaff beam (“forked boom”, event D). Photo: MMT/Nord Stream 2.

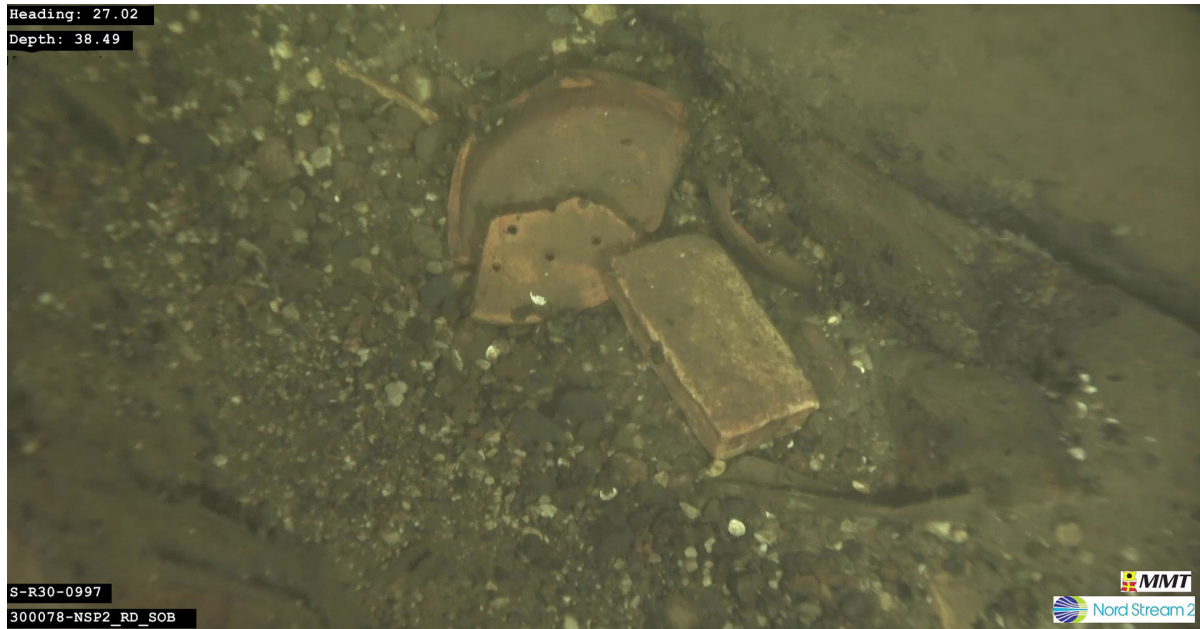
Just inside the hull, a few meters from the stern on the starboard side there are an area with some bricks, ceramics, one ceramic strainer (Fig 26, event A). A similar strainer at Skeppsholmen, Stockholm was dated to 18th century (Hansson 2016:81). Just forward of the strainer is a ceramic plate (event B). This area is probably the remains of the ships galley.

It's hard to date the ceramics more exactly, but in all the type of bricks, the strainer and plate makes indicates an 18th century dating (Bäck 2018).

**FIG. 26.** One of several bricks (possible rest from ships galley), ceramics, a strainer (event A) was filmed by ROV 2019. Photo: MMT/Nord Stream 2.

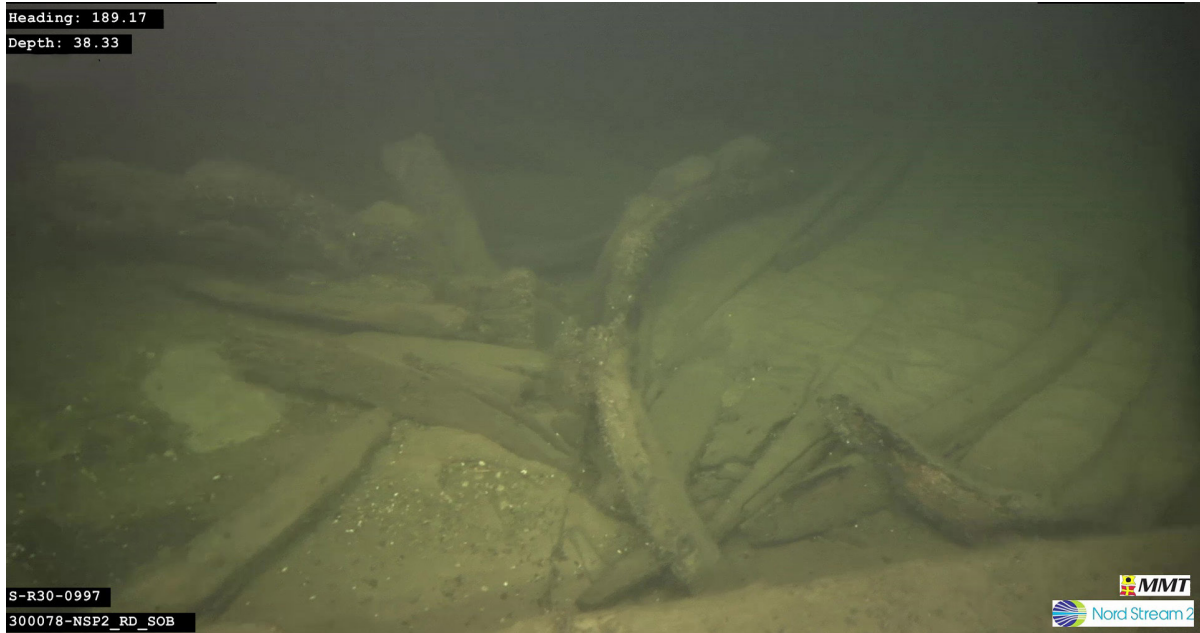
**FIG. 28.** The rounded stern. The loose rudder is partly visible on the far lower right.  
Photo: MMT/Nord Stream 2.
