SJÖHISTORISKA MUSEET  
ARKEOLOGISK RAPPORT NR 2019:5

# Nord Stream 2

Archaeological analysis of ROV-films

Baltic Sea, Swedish EEZ

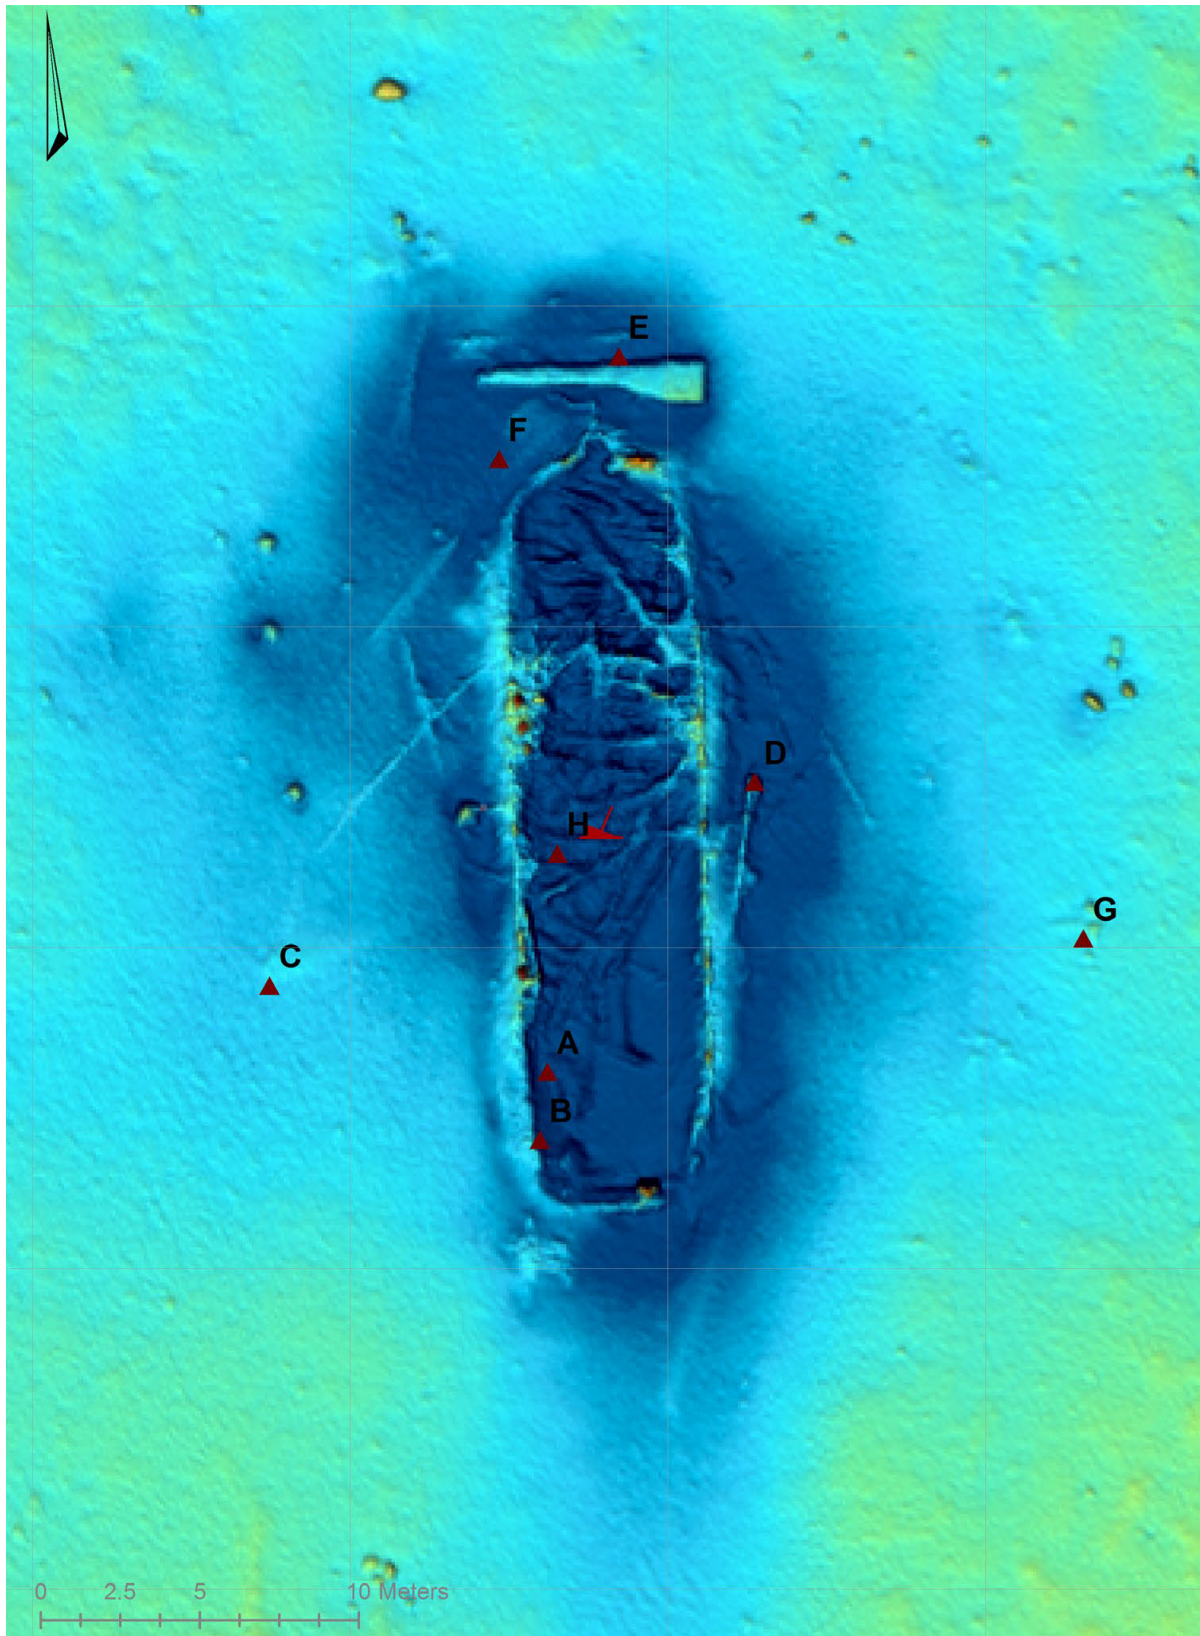
It has a height of just 1, 4 meter, so it's highly degraded, and because it lies on just 38 meters depth it's probably affected both by waves, currents and trawling, as parts of fishing nets are visible on the wreck.

**FIG. 31.** Multibeam image of wreck S-R30-0997. MMT "Events A-H. A: Broken ceramic pieces, B: Pot lid (ceramic plate), C: Wooden board, D: Port beam - Forked boom, E: Rudder, F: Starboard aft quarter – wreck structure, G: Anchor, H: Block / pulley. MMT/Nord Stream 2.
