VRAK – MUSEUM OF WRECKS
ARKEOLOGISK RAPPORT 2019:20

NORD STREAM 2

ARCHAEOLOGICAL MONITORING OF FIVE SHIPWRECKS

BALTIC SEA
SWEDISH EEZ

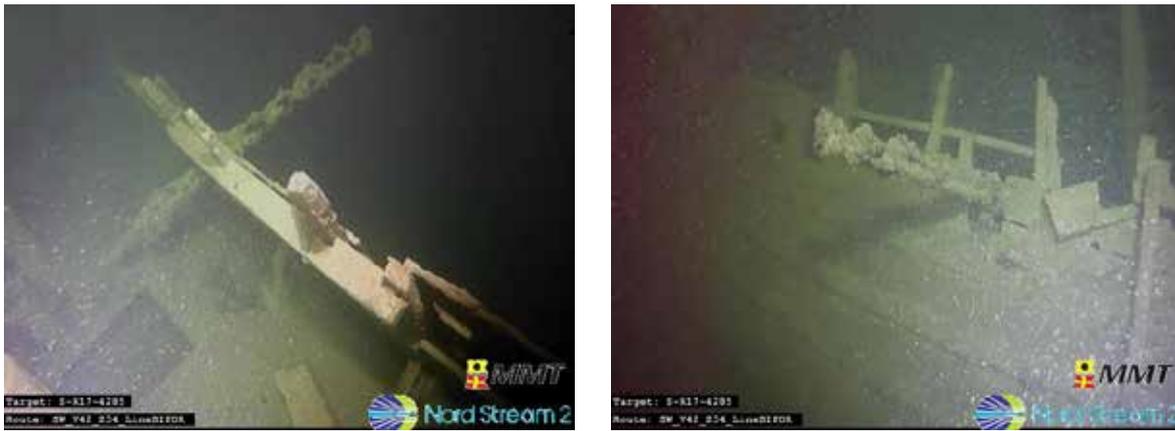
FIGURE 2. Photos on the possible swivel gun on the starboard side. Pre-construction (Event A). Photo: MMT/Nord Stream 2.

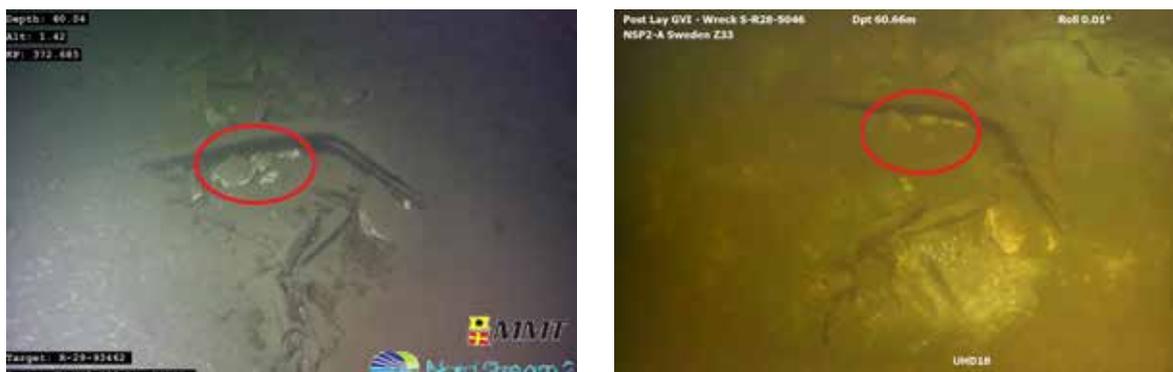
As seen from earlier inspections, the sedimentation seems to vary on this site (Fredholm 2019:26). For example event A; a ship timber and stones seems to have different sedimentation on the postlay-inspection. The sediments on the sea bottom and the wreck seems to be volatile and light. Therefore the sedimentation seems to change from time to time. The wreck as a whole does look unchanged between 2009 and the postlay-inspection 2019.

FIGURE 4. Event A. Photos of ship timber and stones. Pre-construction (left) and post lay (right). Some of the stones seems to be more covered by sediments post-lay than pre-lay. Photo: Allseas and MMT/Nord Stream 2.

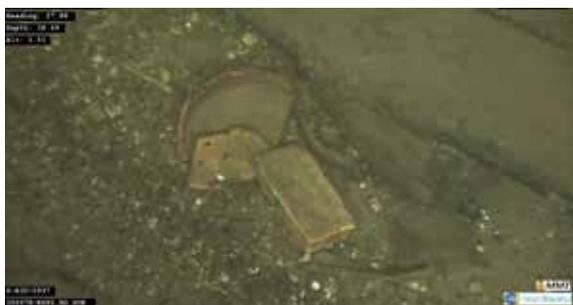
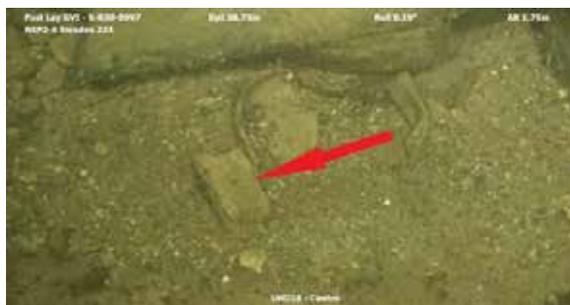
Event A: a brick has moved around 20 cm.

FIGURE 5. Event A, where a brick has moved around 20 cm. Pre-construction (left) and post lay (right). Photo: Allseas and MMT/Nord Stream 2.

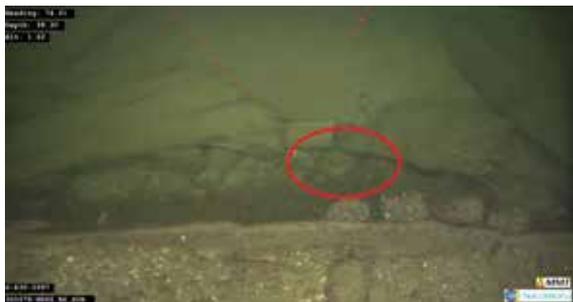
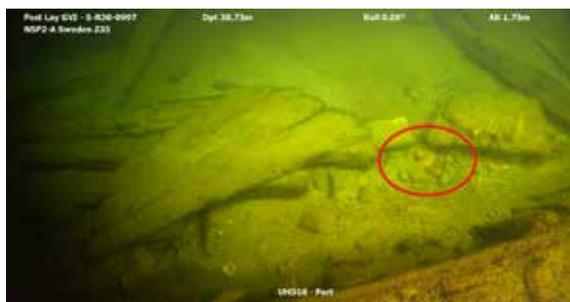
Event B, possible lid pot, a wooden object has

moved according to Allseas. SMTM has hard to see any movement, maybe it’s only a few cm.

FIGURE 6. Event B, possible lid pot, where a wooden object might have moved a few cm. Pre-construction (left) and post lay (right). Photo: Allseas and MMT/Nord Stream 2.

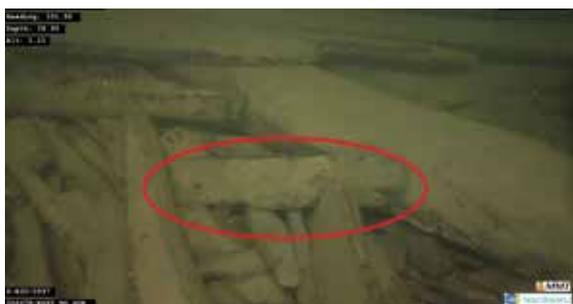
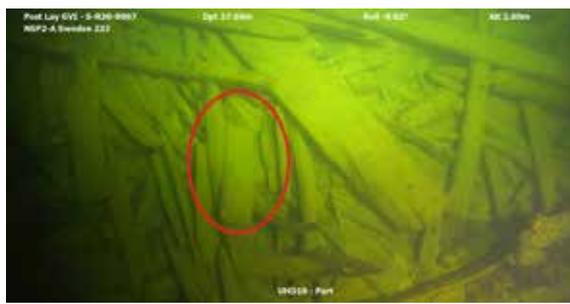
Event H, a block and planks has moved and it’s possible that the plank has moved the block slightly.

FIGURE 7. Event H; a block, where a plank has moved. Pre-construction (left) and post lay (right). Photo: Allseas and MMT/Nord Stream 2.
