**VRAK**  
MUSEUM OF  
WRECKS

## **UNDER THE SURFACE**

STORIES FROM VRAK – MUSEUM OF WRECKS

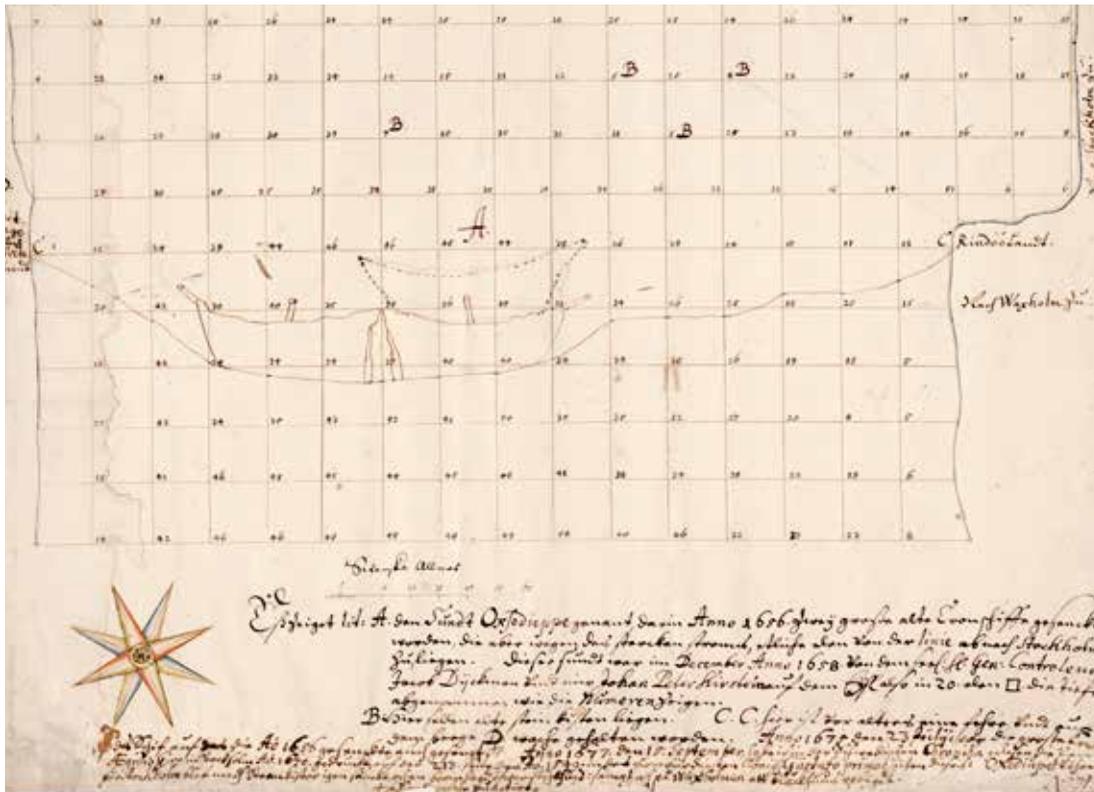
A sketch from 1659, updated in 1675, showing plans to sink another large warship in the Oxdjupet strait at Vaxholm and stack it on top of two already sunken ships.

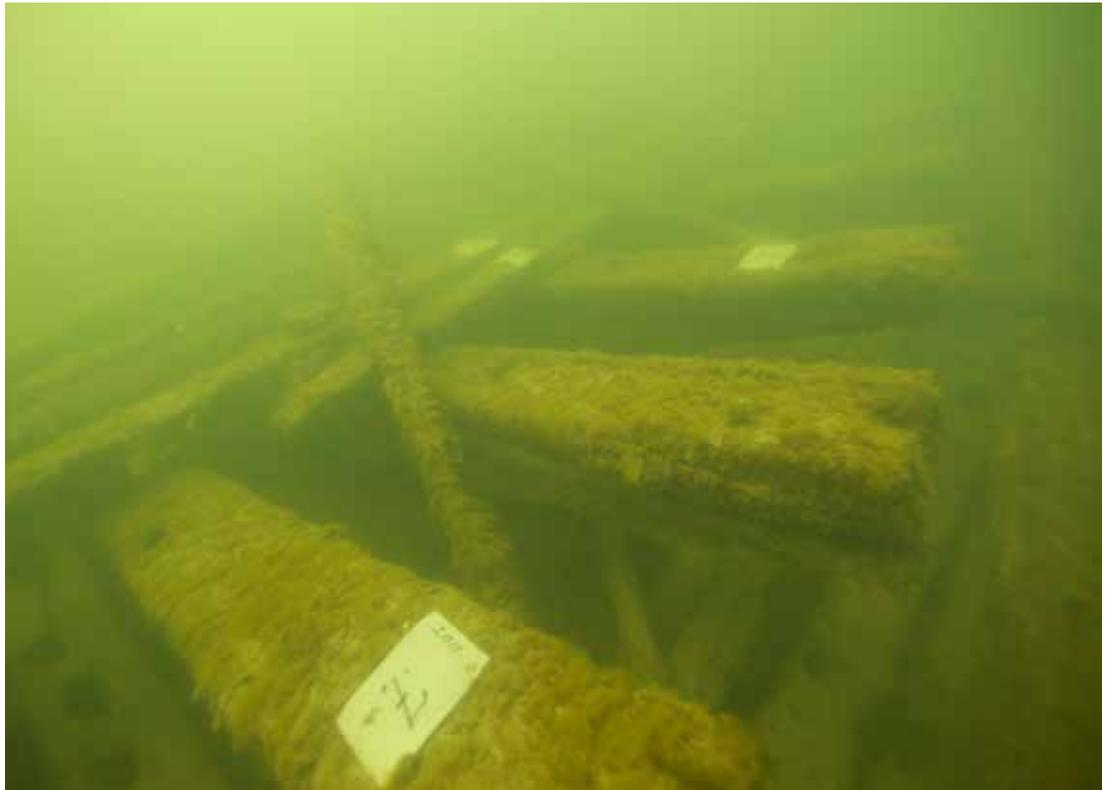
Dendrochronological sampling of one of the wrecks at Suomenlinna. The frames and inner planking of the wrecked skeleton.

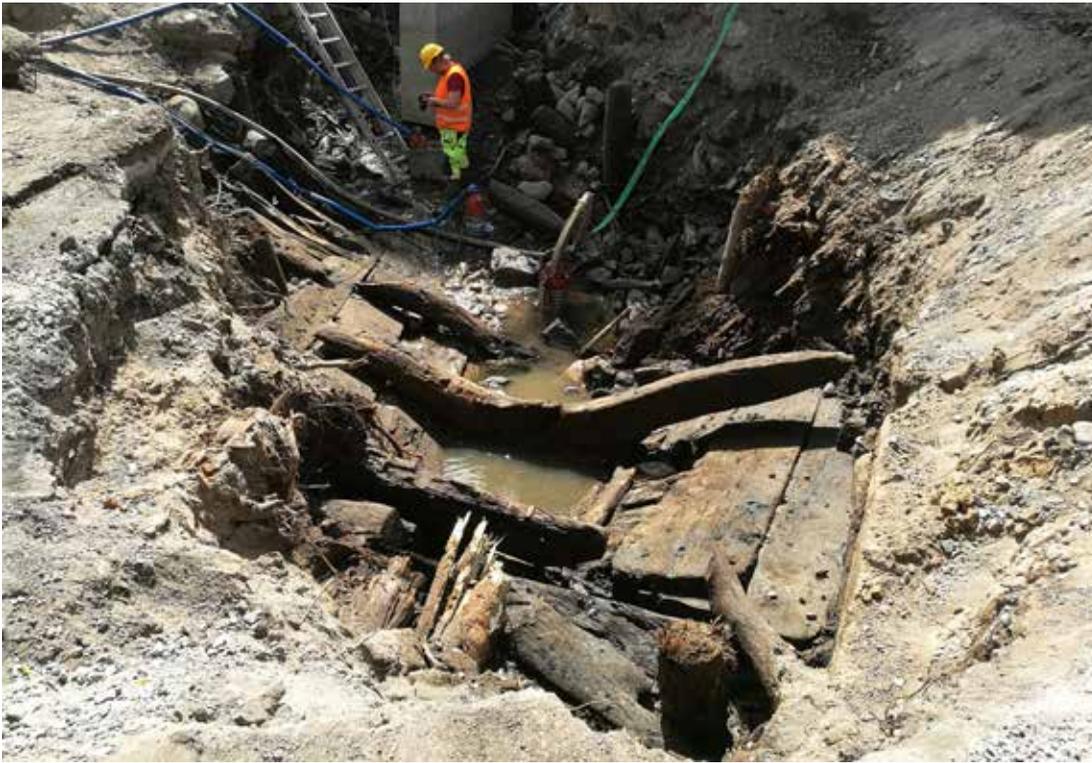
When the quays on Skeppsholmen in Stockholm were to be renovated in 2017, Gustav II Adolf's flagship *Scepter* had lay hidden for several hundred years. The ship was repurposed as a foundation for a careening dock where ships were repaired around 1640. Note how the piles from the careening dock go straight through the wreck. The photo also shows *Scepter's* heavy trimming in the stern and, above the interior trim, riders. Both were used to carry up the heavy gun decks and relieve the hull.

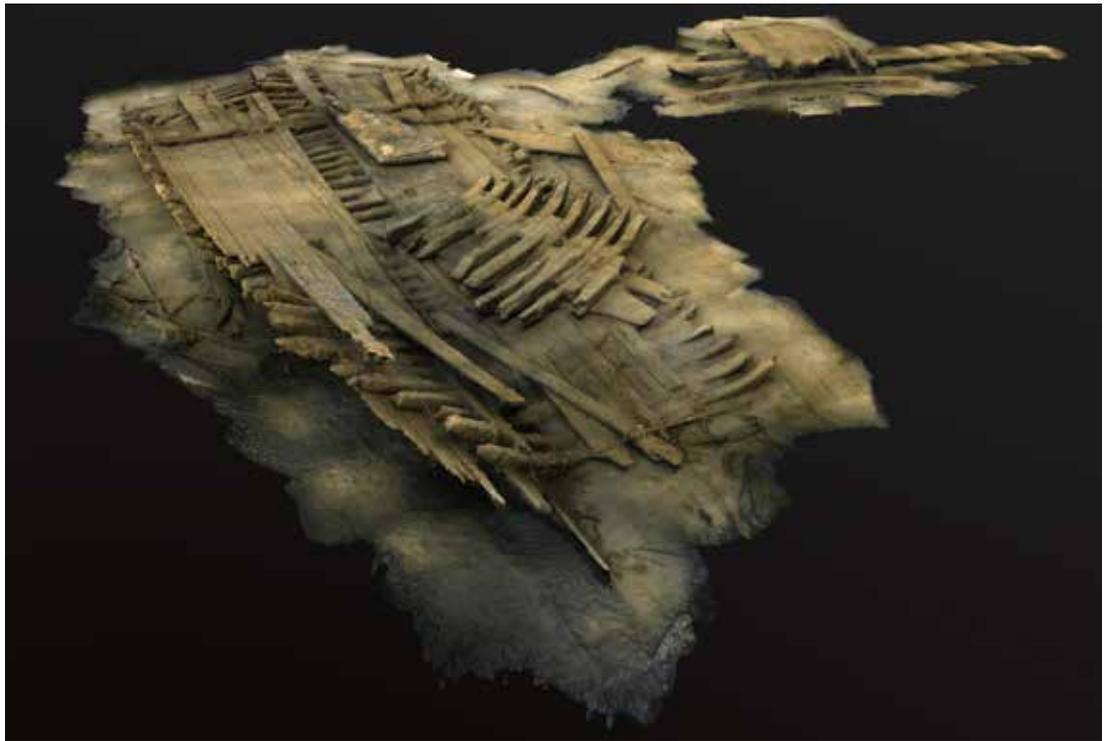
After archaeological excavations, the wreck was moved to another underwater location to protect and preserve it. This is a photogrammetric image of the moved wreck.

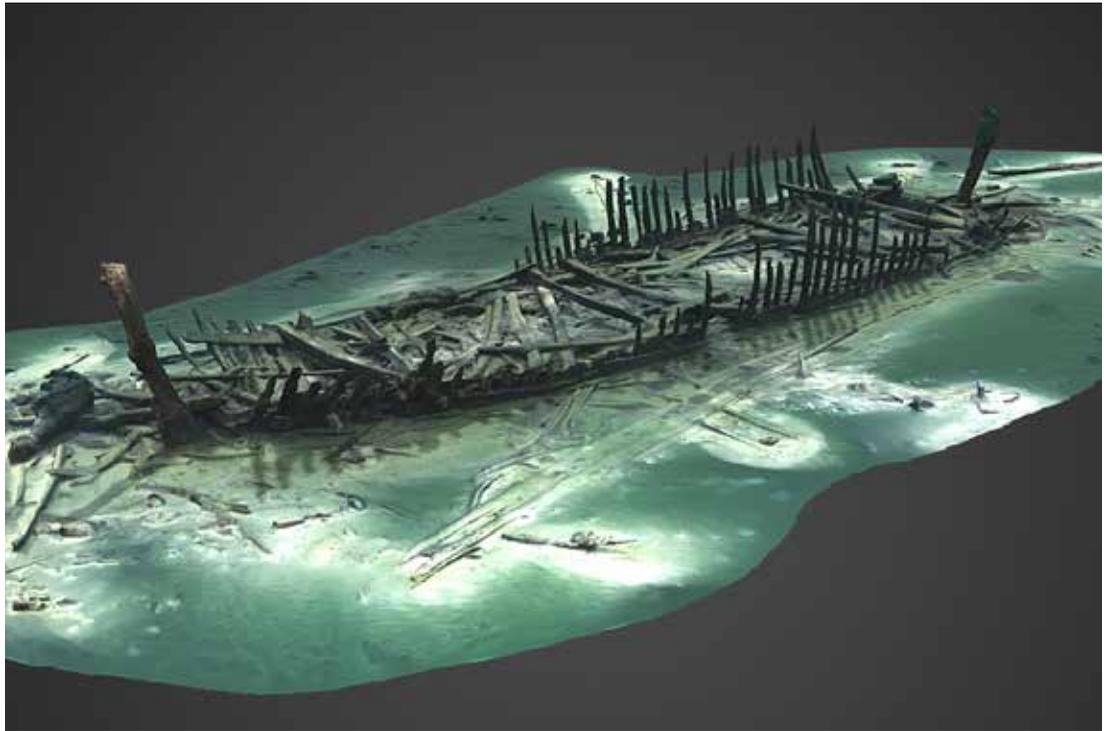
3D model of *Resande Man*'s wreck site. The frames still rise high on *Resande Man*.

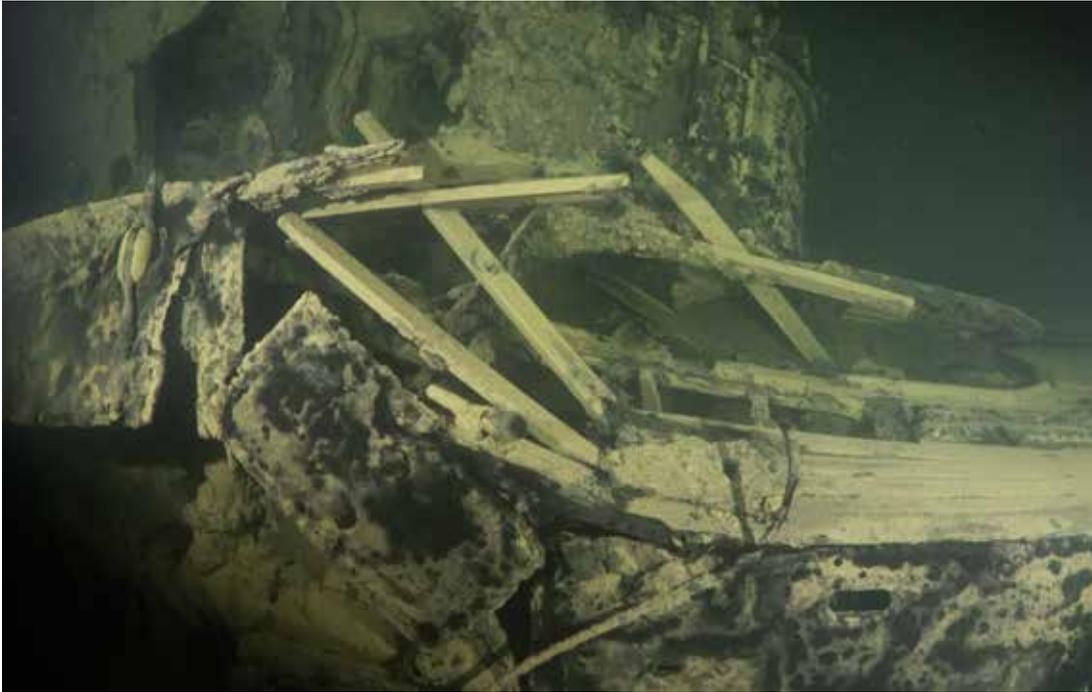
The image shows significant damage to the hull at the conning tower, a gap, and boards from the wooden deck.

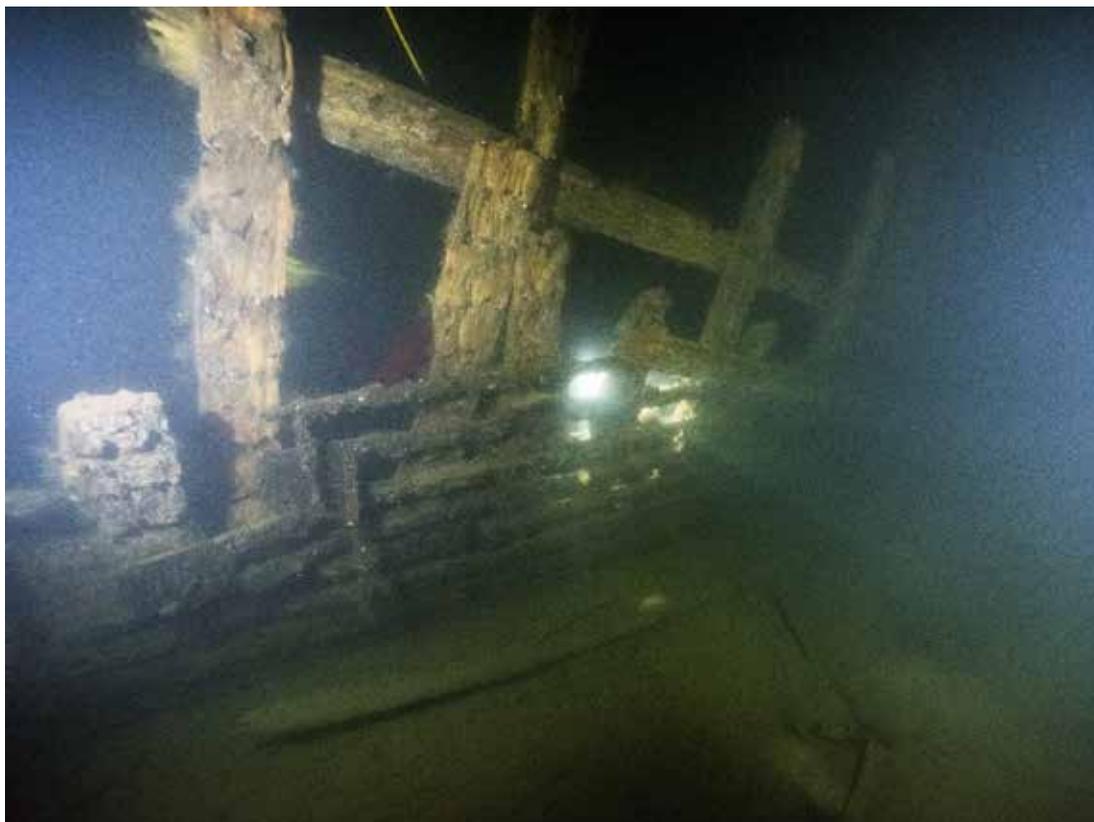
The wreck's clinker-built hull is intact and the planking is severely eroded. Just the rivets are holding it together. The frame is sticking up 3–4 metres. On the inside you can see the shelfpiece.

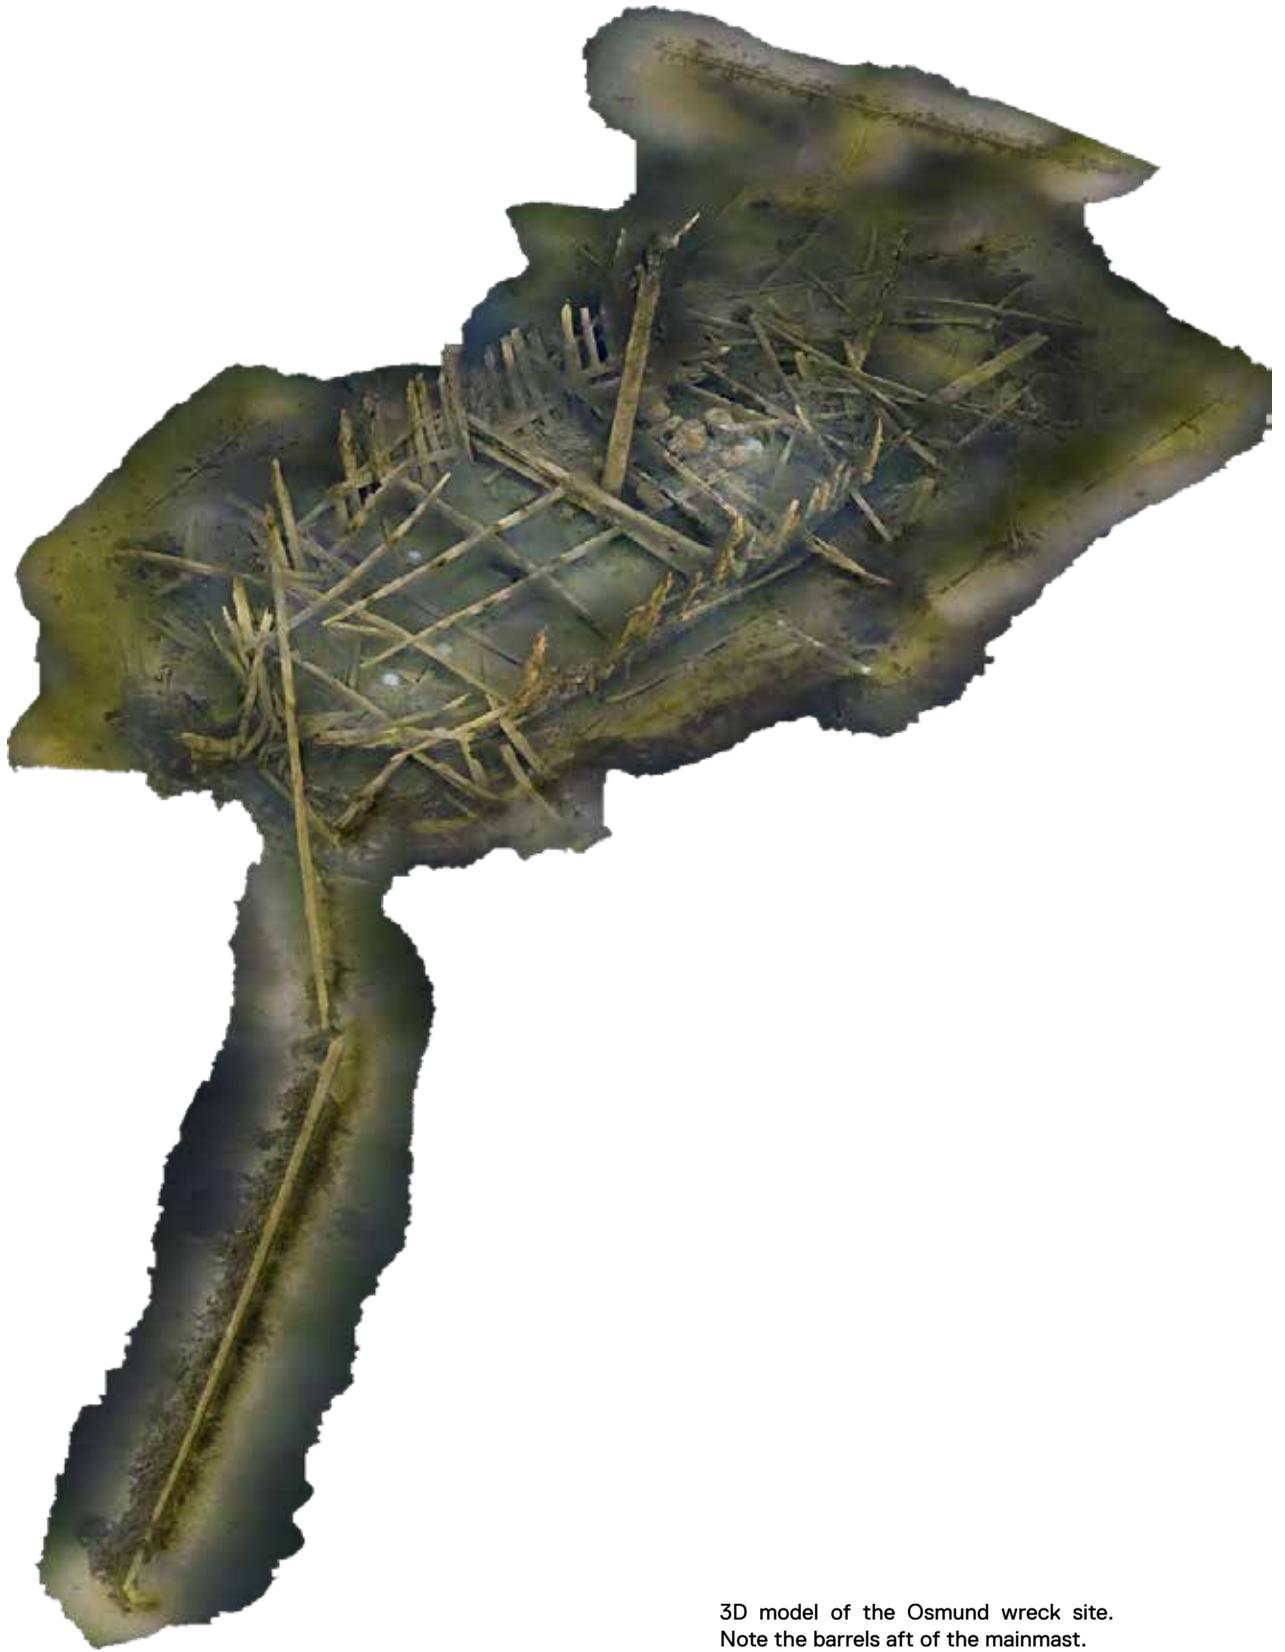
3D model of the Osmund wreck site.  
Note the barrels aft of the mainmast.

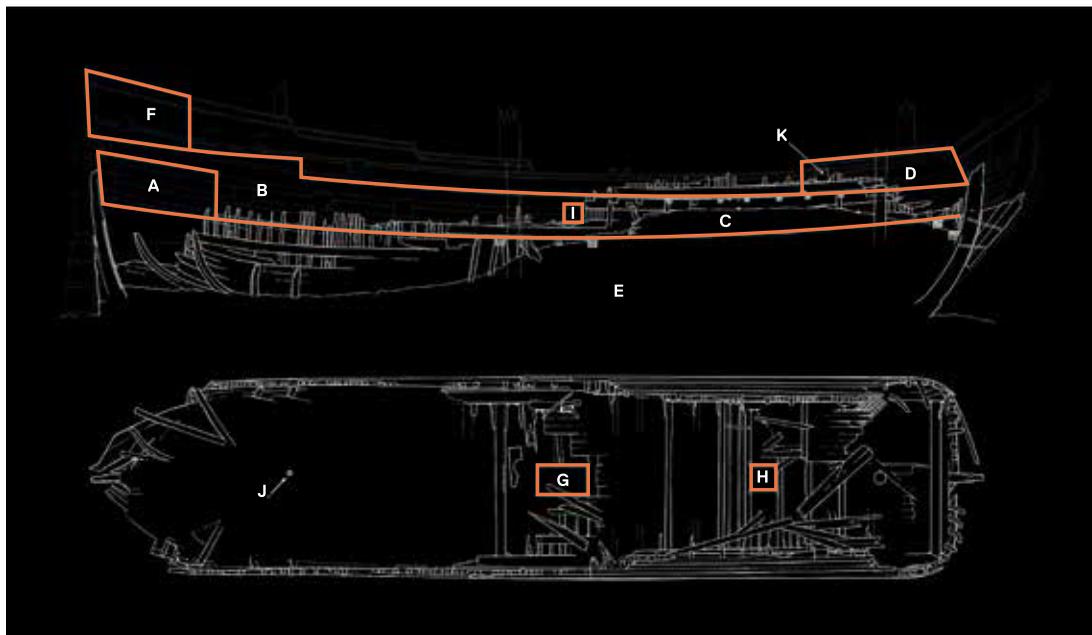
Sectional drawing and plan of the unusually large fluit *Anna Maria*'s hull. A fire caused the ship to sink in 1709. The burnt section is indicated in a contemporary drawing. The letters indicate the following: A: cabin, B: galley, C: lower deck, still loaded with pinewood planks, D: beakhead, E: the hold loaded with iron goods, F: poop, G: hatch for the hold, H: hatch, I: cargo port, J: bilge pump, K: porthole.

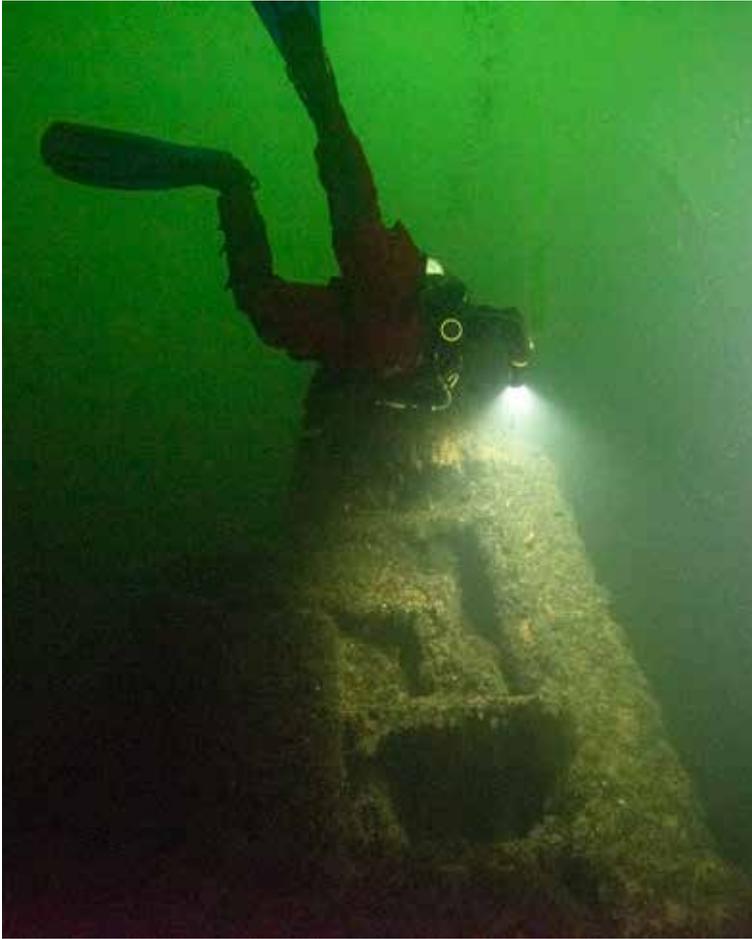
On its last voyage, *Castlewood* was en route from Kronstadt to Rotterdam. The photo shows the large steam engine from aft.

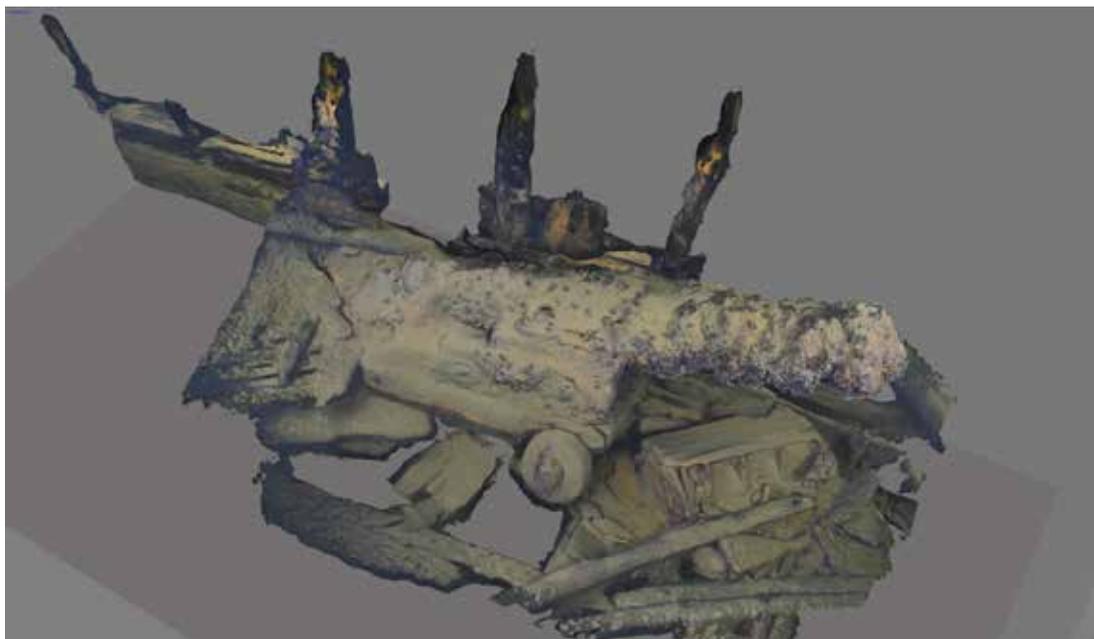
3D model of a gun at the Dalarö wreck/*Bodekull* in the Stockholm archipelago. Although 3D models are often made of entire shipwrecks, they can sometimes be created for specific details, as shown here. The advantage to this is that a higher resolution can be obtained.
